# Three Rivers Fountain

## Computer Radiography of The Murray Statue

April 2017

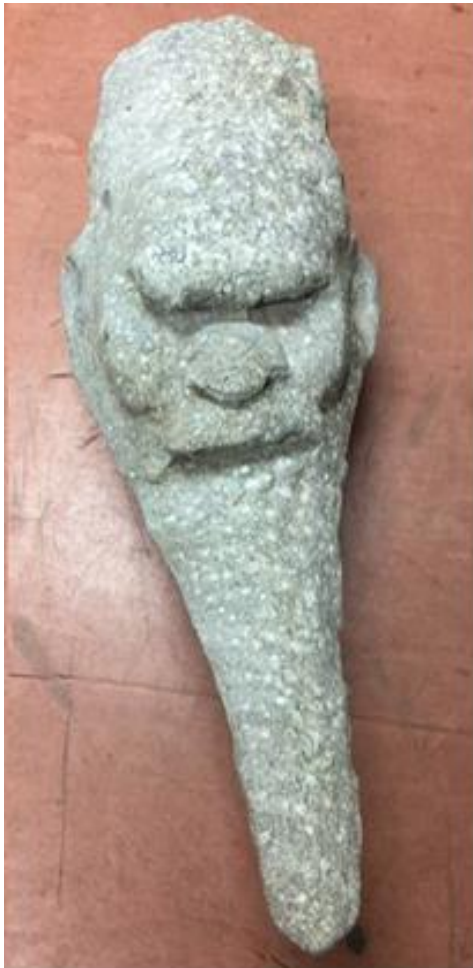
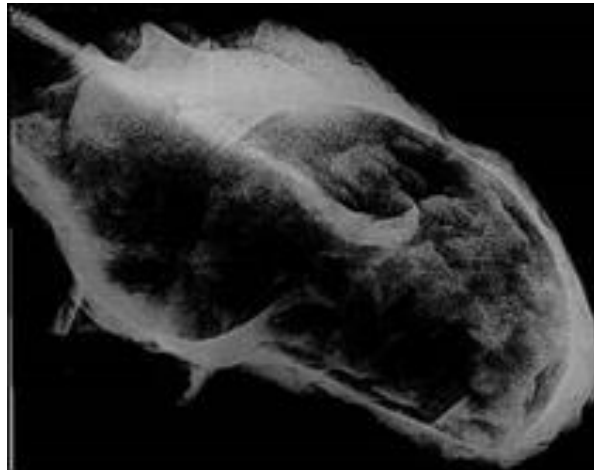
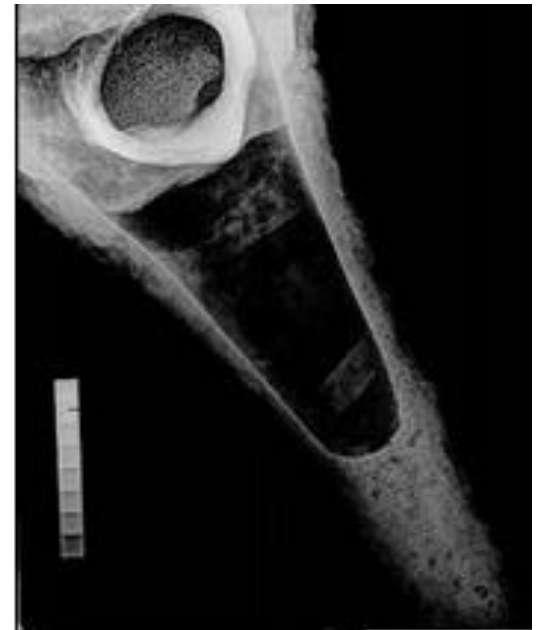
## Head section

<5mm wall  
thickness evident

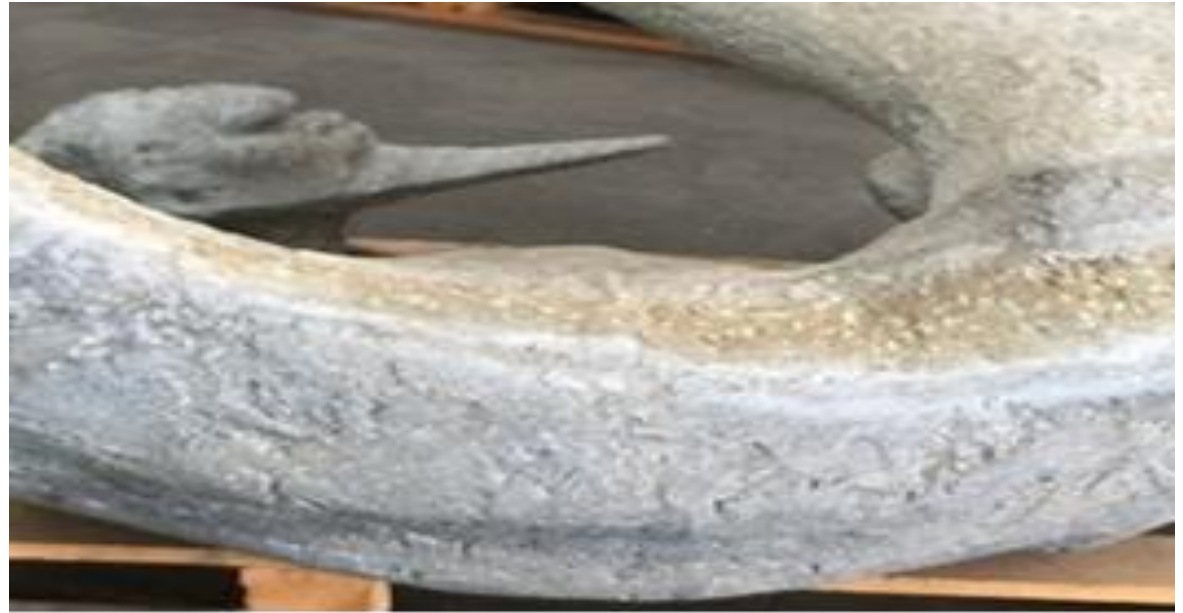
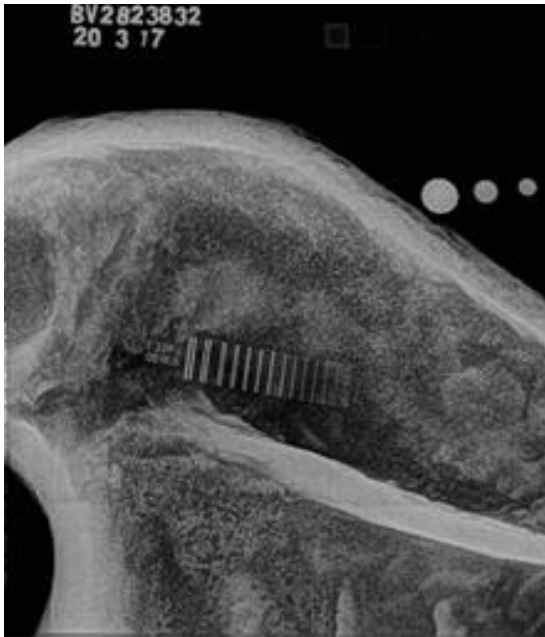
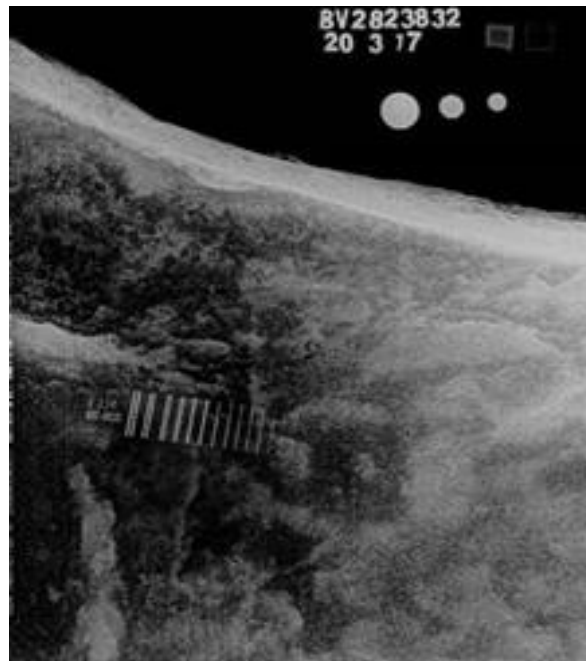
# Torso

No evidence of  
cracking- Thickness  
> 10mm

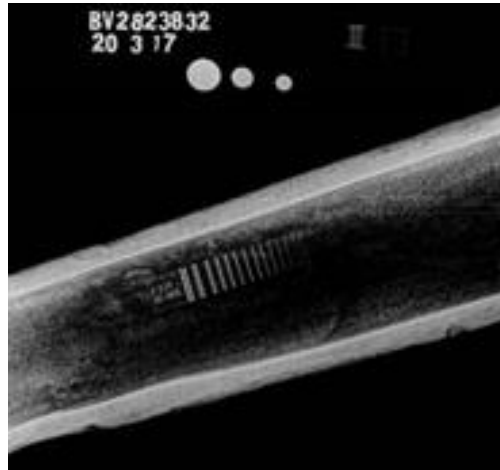
# Upper arms

Pitting evident  
with parent  
metal  
thickness  
> 6mm

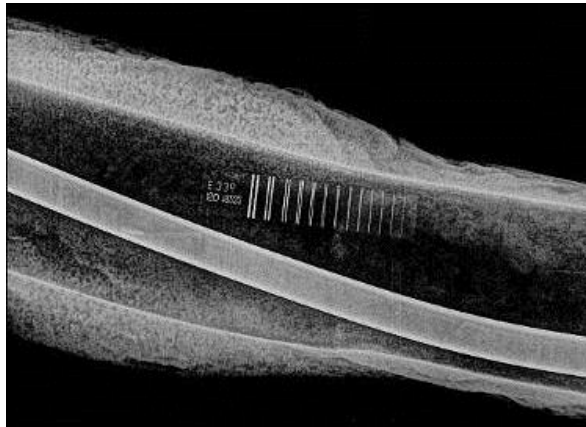
Welded section  
indicates a  
partial  
penetrated  
weld with  
cracking  
evident.

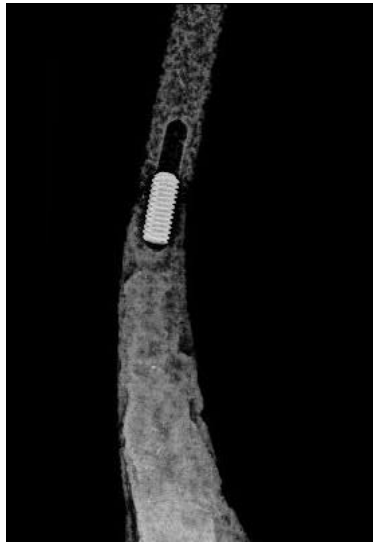
Visible areas of corrosion evident, wall loss located at the neck area below the head and the lower beak adjacent to the metal insert.

Beak section showing metal insert

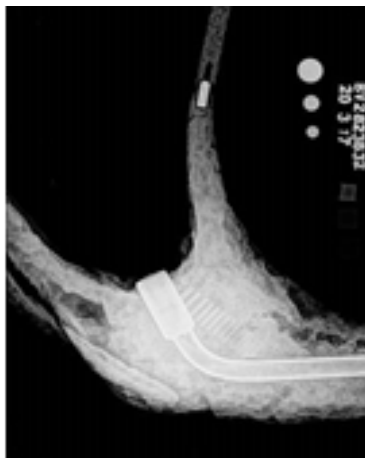
Head section

Parent metal thickness  $>10\text{mm}$   
Water pipe cast into head section.

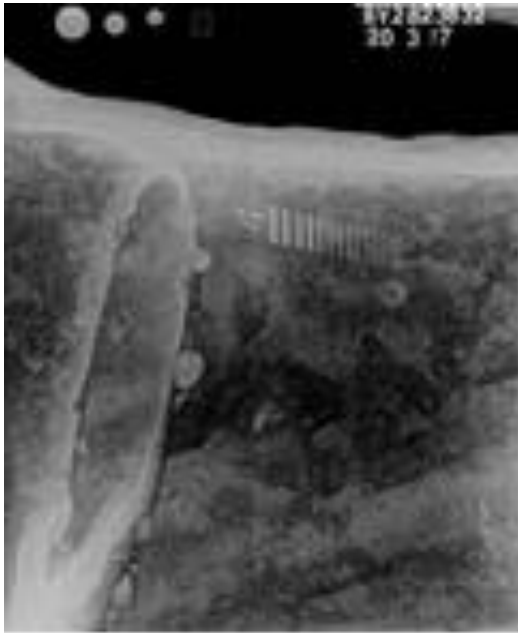
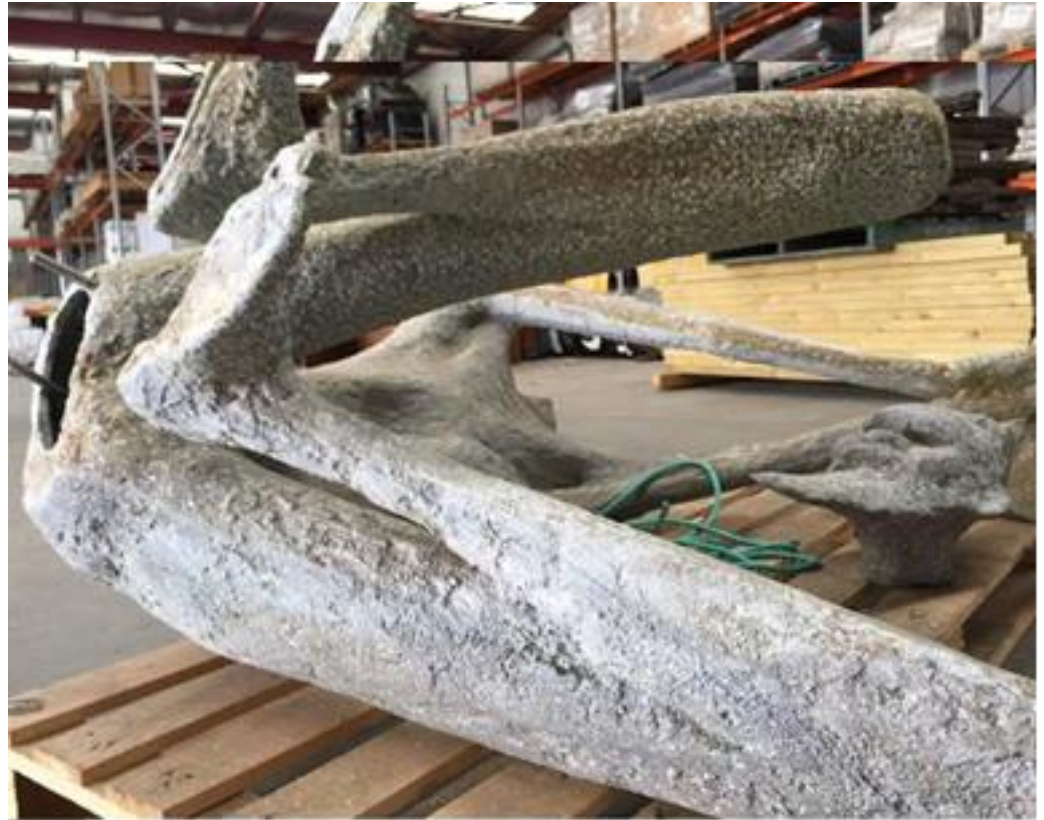
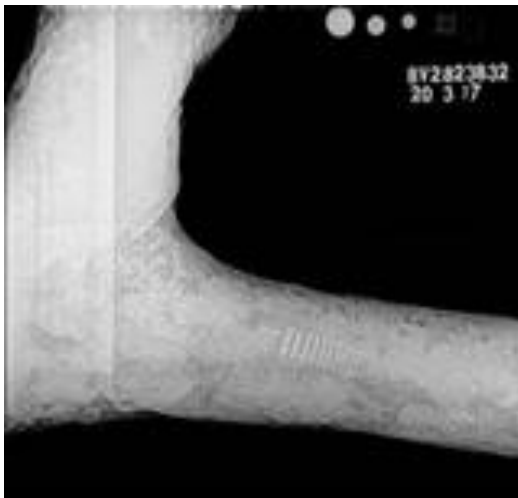
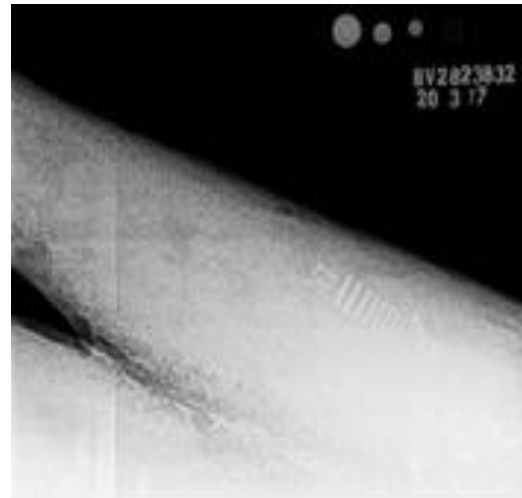
# Lower section

Weld connection of  
leg to hip and leg to  
foot with no  
evidence of cracking.

No significant wall  
loss evident

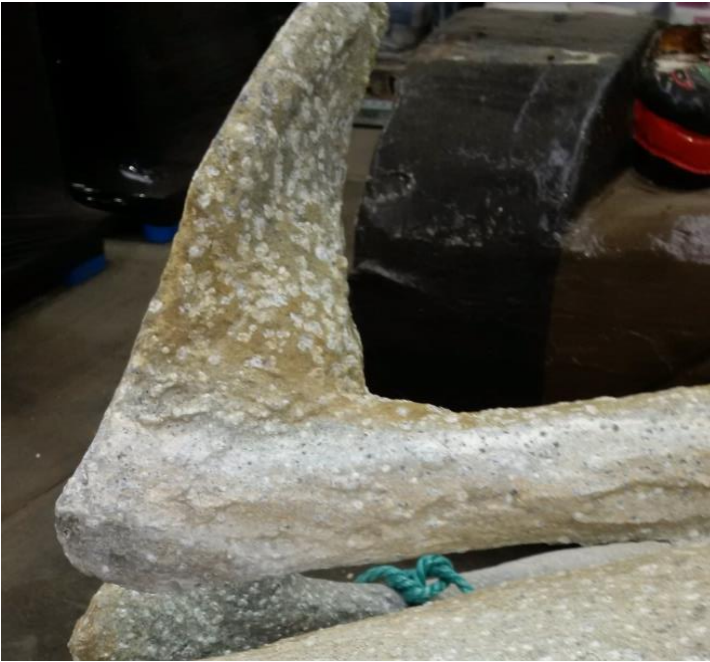
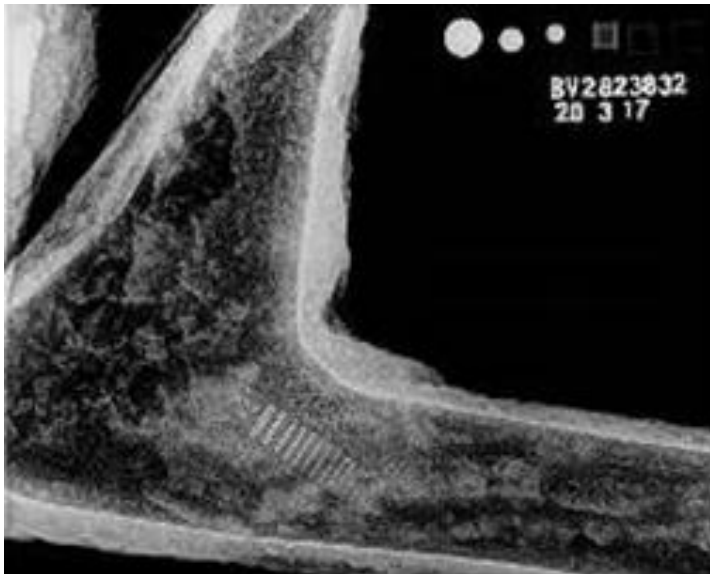
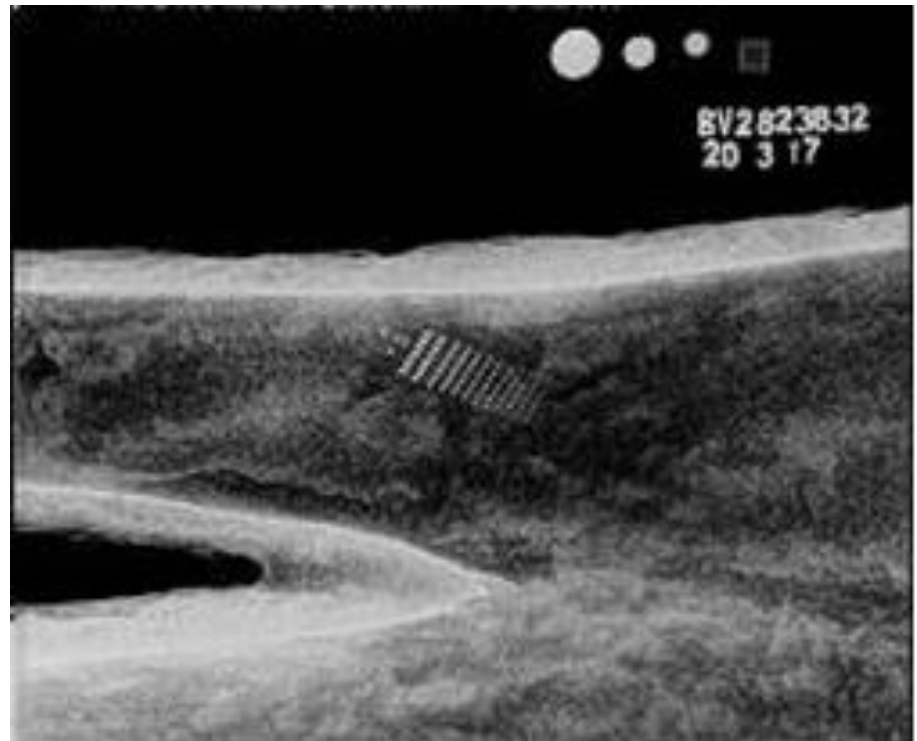
# Foot & thigh

No significant wall loss evident
