# Near field array for inspection of ferritic/ferromagnetic stainless steel (NFA FS)

J. Renaud, R. Demers, M. Wolf, O. Lavoie, S.  
Savard, V. Heredia (Eddyfi)  
T. Mau (Duke Power)  
N. Driessen (EPRI)

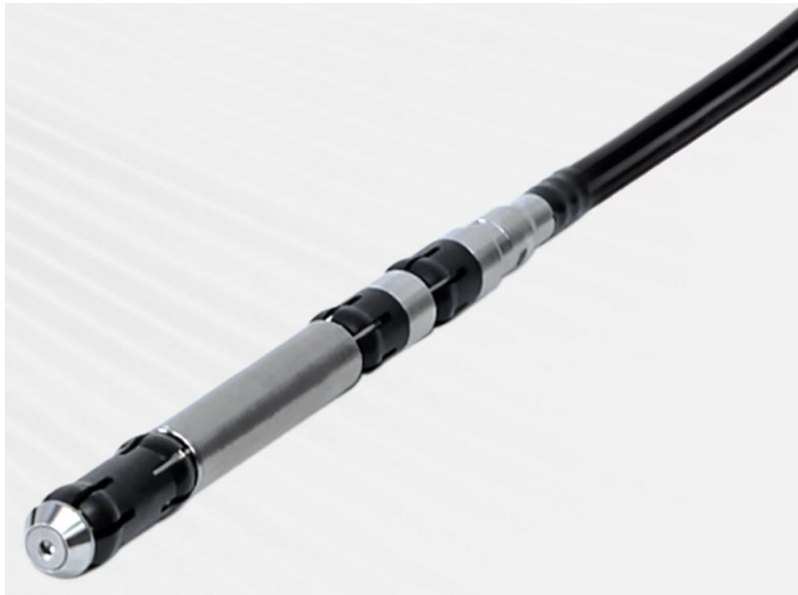
- Numerous prototypes were designed and produced testing different coil layouts, firing sequences, spacing, and frequency response ranges.
- The probe body was designed to share as many components as possible with the popular DefHi™ probe (rugged nylon push tube, replaceable centering devices, titanium outer casing).

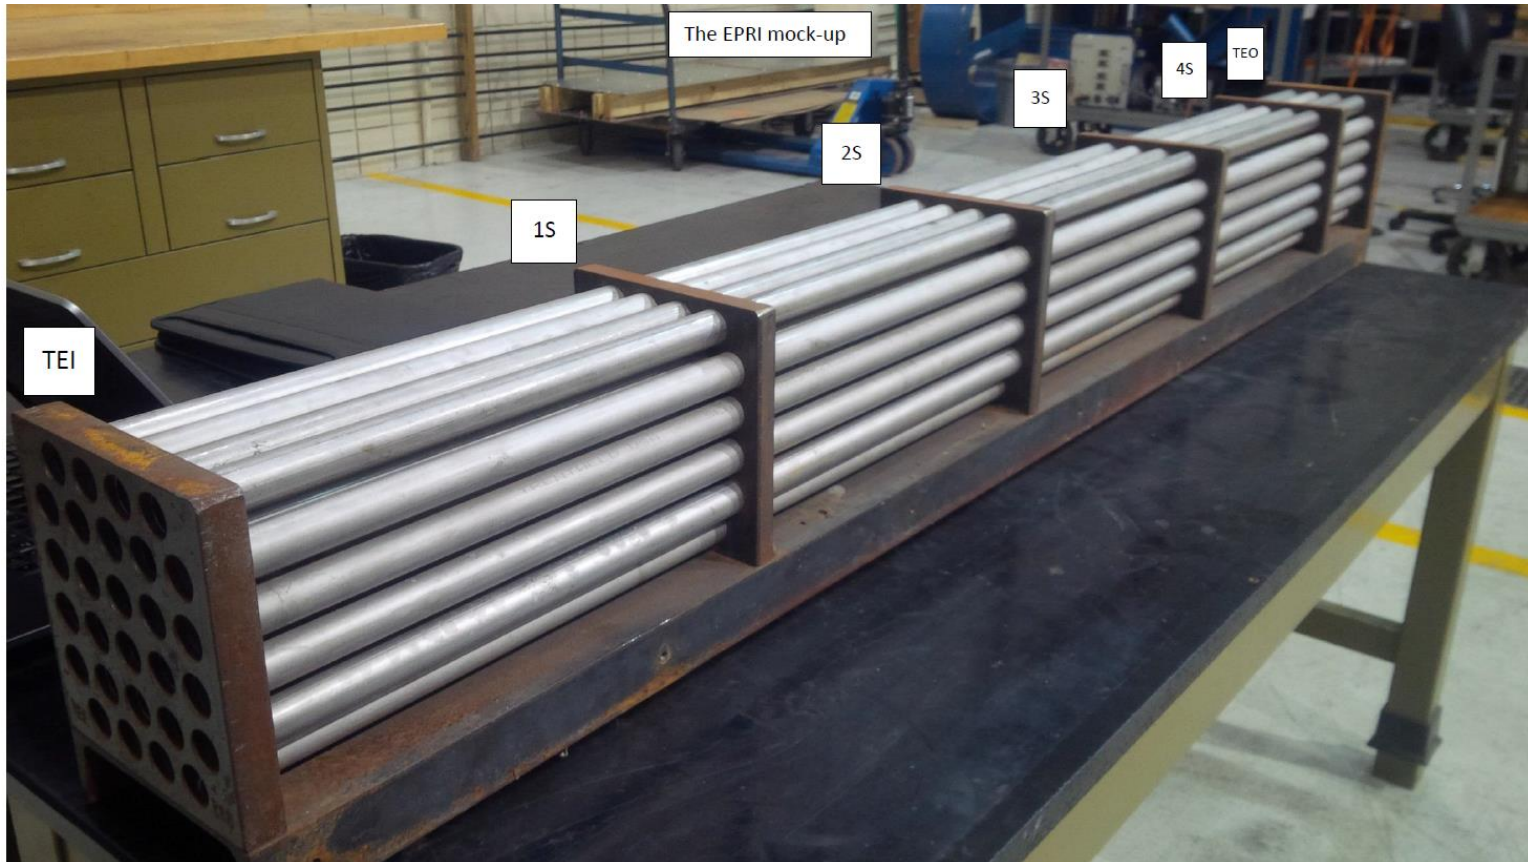
*Photo of the Sea Cure™ mock-up at the EPRI NDE Centre, Charlotte N.C.*

- Laboratory data were collected on the SEA-CURE™ mock-up at the Electric Power Research Institute (EPRI) in Charlotte, North Carolina, 2015 April 08.
- The probe used for the examination was a repurposed 23 mm (0.905") OD NFA probe originally developed for the inspection of carbon steel pipes for ID flaws.
- The EPRI mock-up contained 21, 25.4 mm OD x 0.71 mm WT (1" x 0.028") SEA-CURE™ tubes, 13 of which were unflawed.

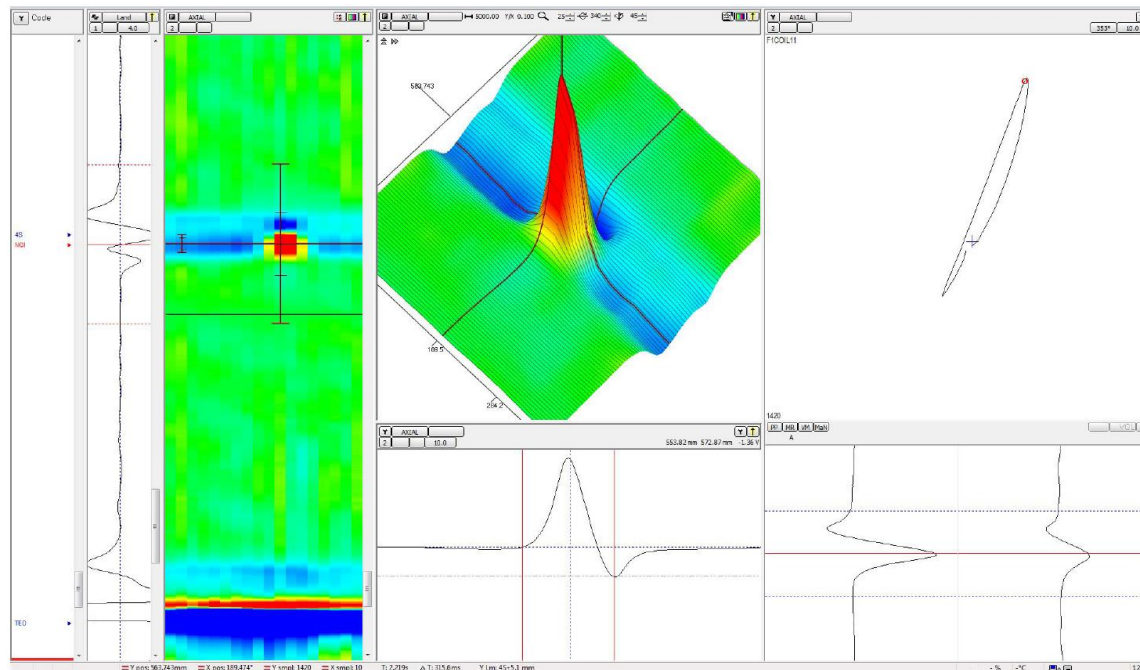
- The NFA probe was also able to detect and characterize axially and circumferentially oriented EDM notches simulating cracking in the tube

Axially oriented 100% TW EDM notch below a carbon steel support in the Sea Cure™ mock-up at the EPRI NDE Centre, Charlotte N.C.

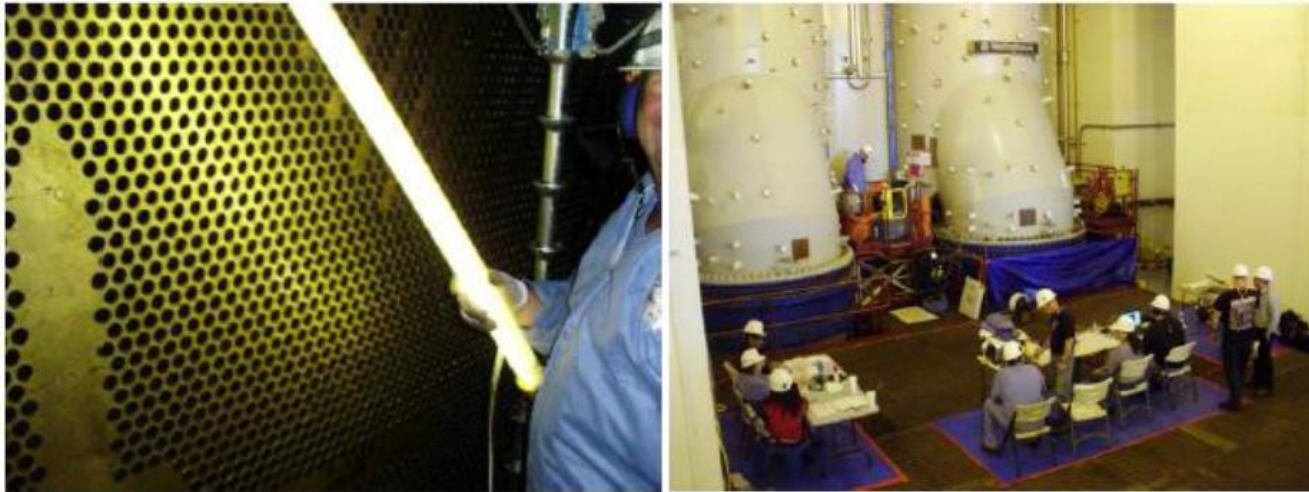
Photos of the main condenser tube sheet face and inspection staging area

- Shearon Harris Nuclear Plant (HNP) North Carolina (PWR – Westinghouse) main condensers - 25.4 mm OD x 0.71 mm WT (1" x 0.028") SEA-CURE™
- 200 tubes selected for inspection<sup>2</sup>
- HNP previously experienced a tube leak in this system due to cracking at a support plate. This crack was undetected by magnetic saturation bobbin probes.

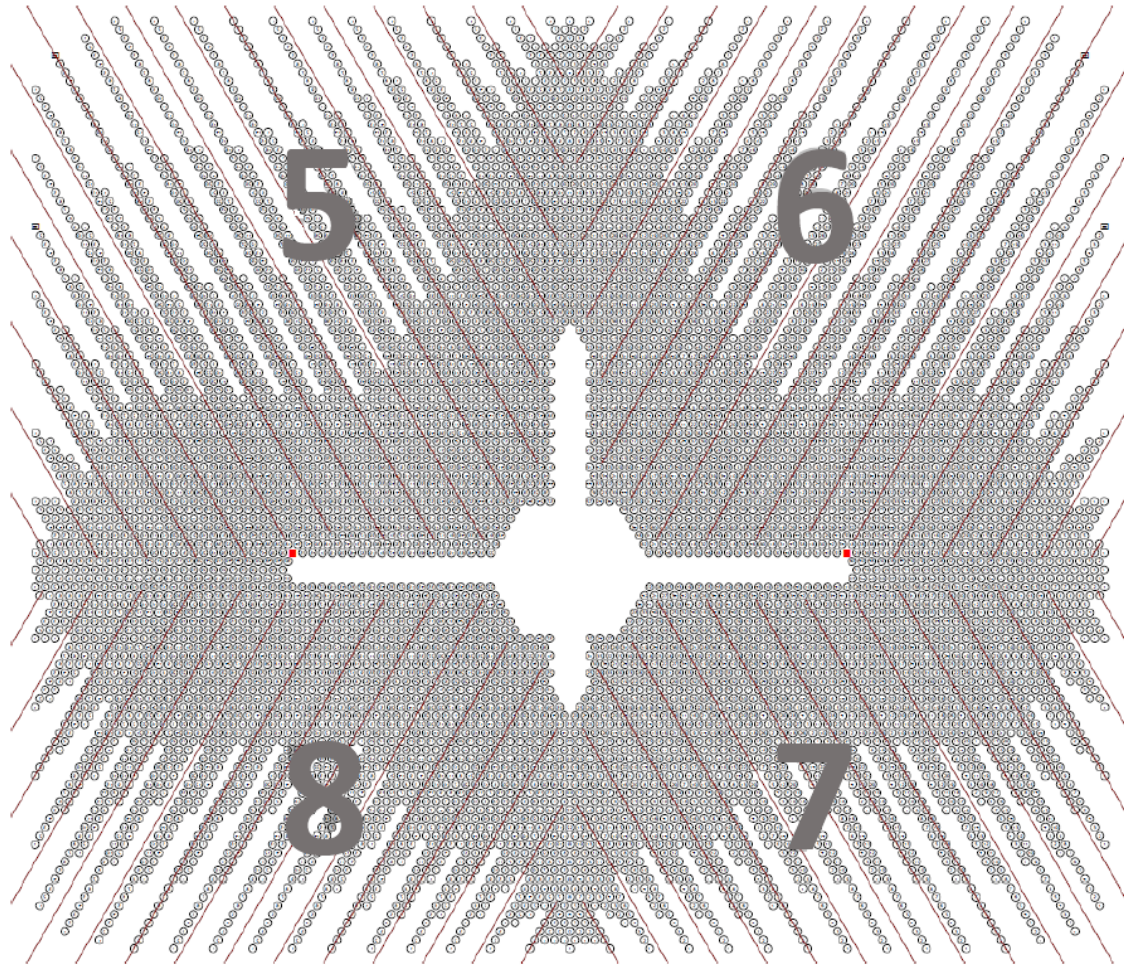
Tube sheet map showing four of the sixteen quadrants that made up the two main steam condensers

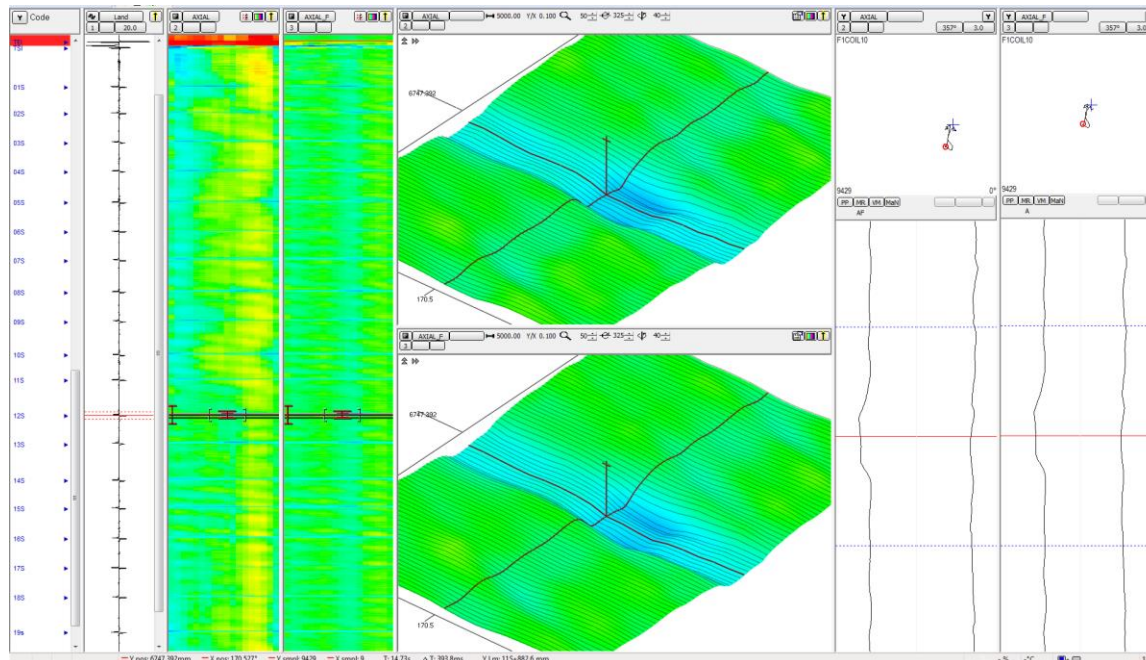
A tube with no detectable degradation

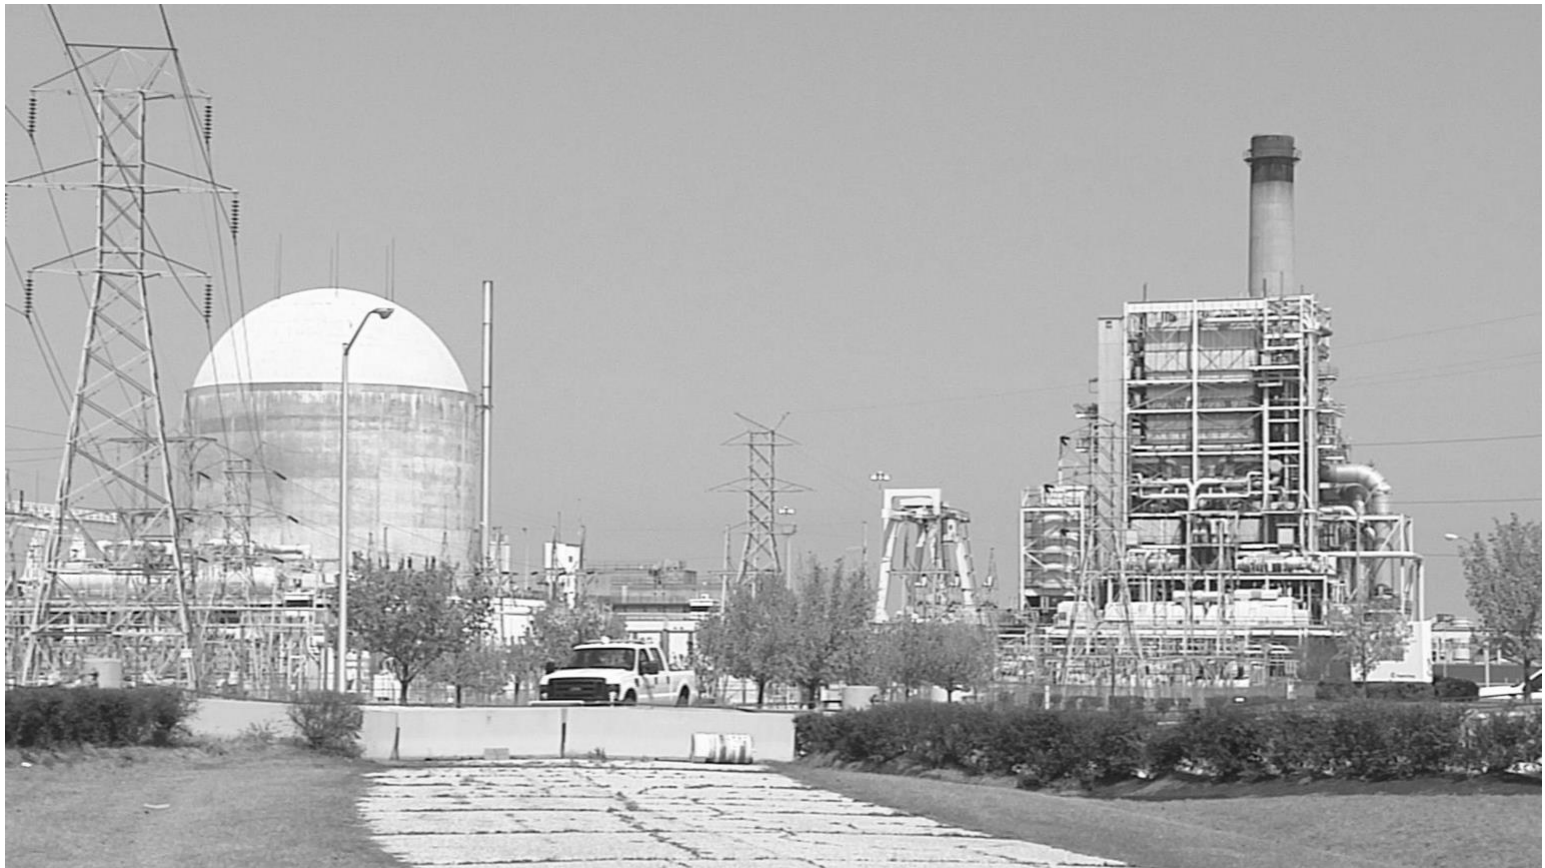
- Robinson Nuclear Plant South Carolina (PWR – Westinghouse Model) main condensers – 2017 March

- 439 SS – 19.05 mm OD x 0.71 mm WT ( $\frac{3}{4}$ " OD x 0.028" WT)
- Inspection of record
- Tubing featured some minor pitting, axial cracking (both possibly related to welded seam tubing) and low level erosion.
- Data were collected with the most *mature* version of the NFA FS and all detected indications were rescanned with a full saturation bobbin probe for comparison.
