Application of NDT in Fatigue Assessment of Steel Bridges

Faramarz Rahiminia, Ph.D., P.Eng.

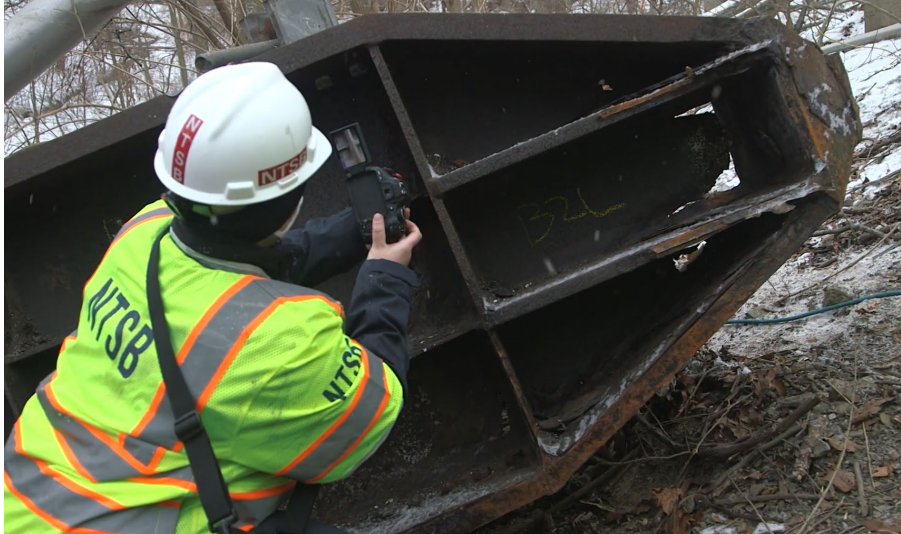
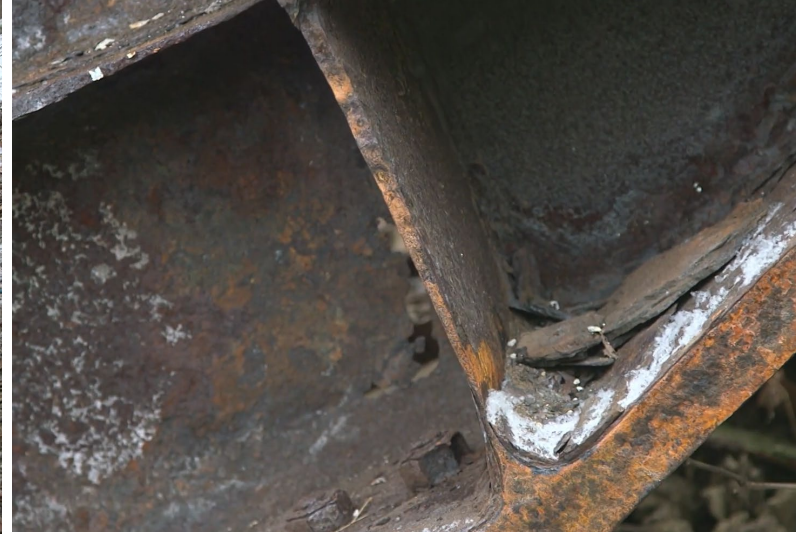
Images of the early investigation done by NTSB

Severe corrosion!

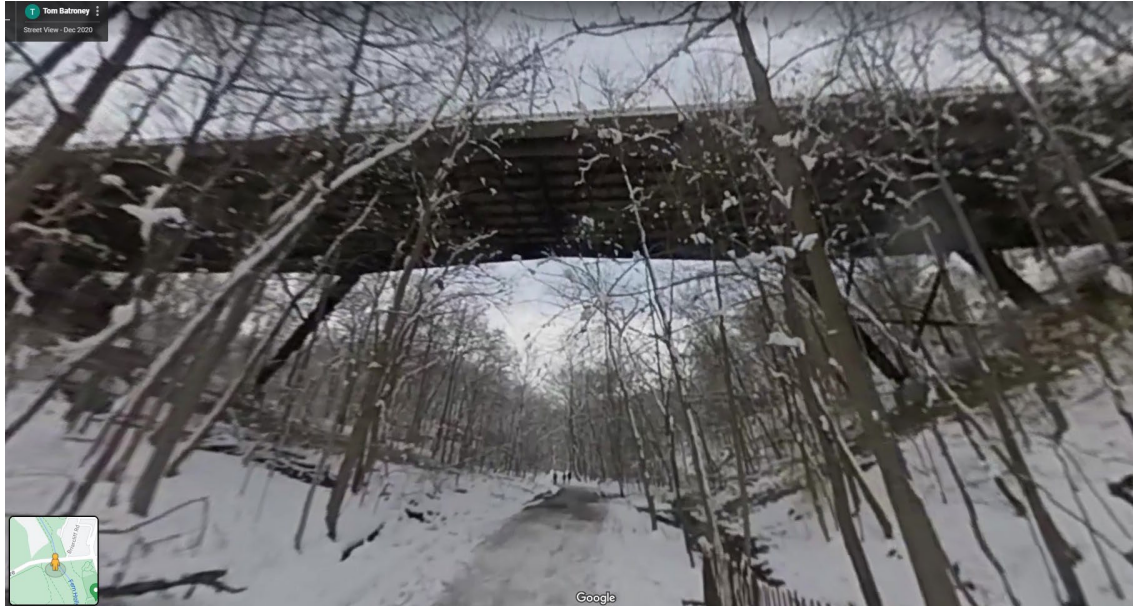
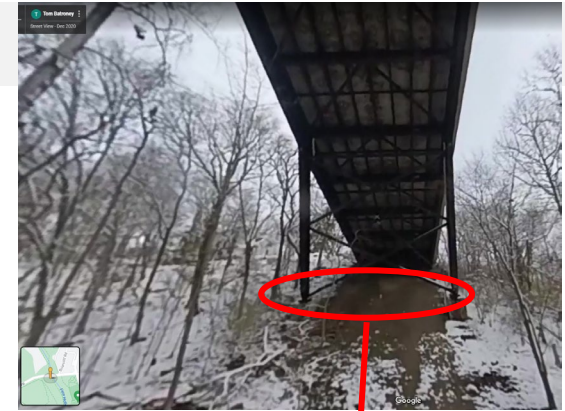
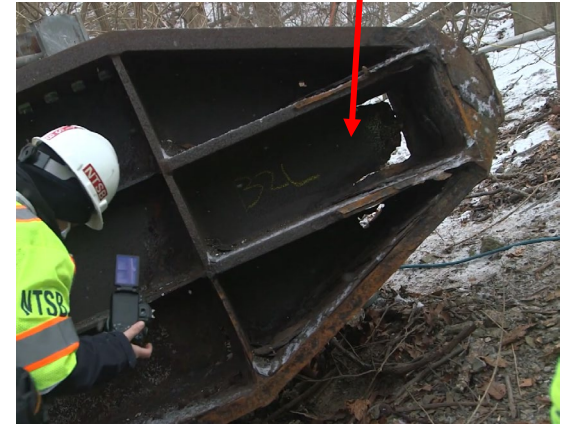
Google map images- December 2020

Columns were severely corroded!

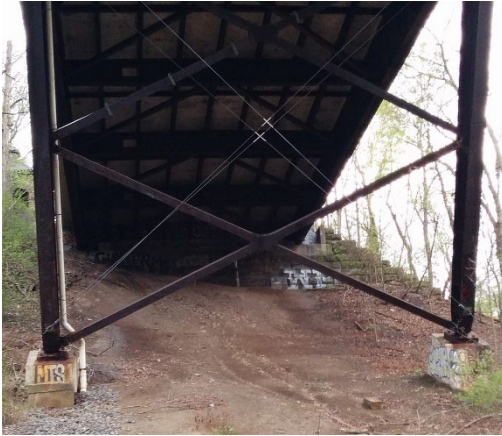
2015

Deterioration of the bridge!

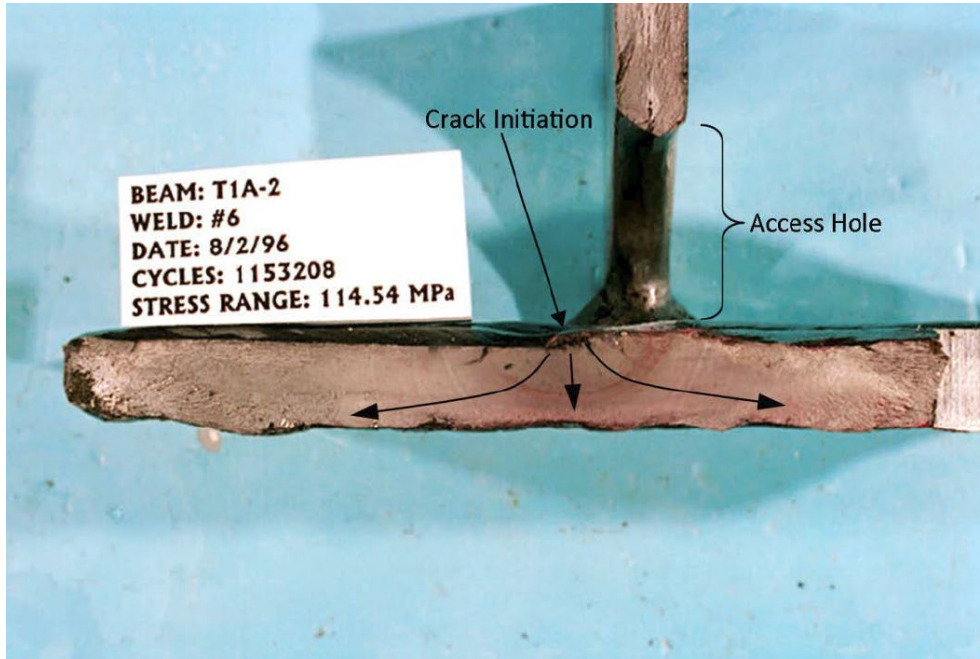
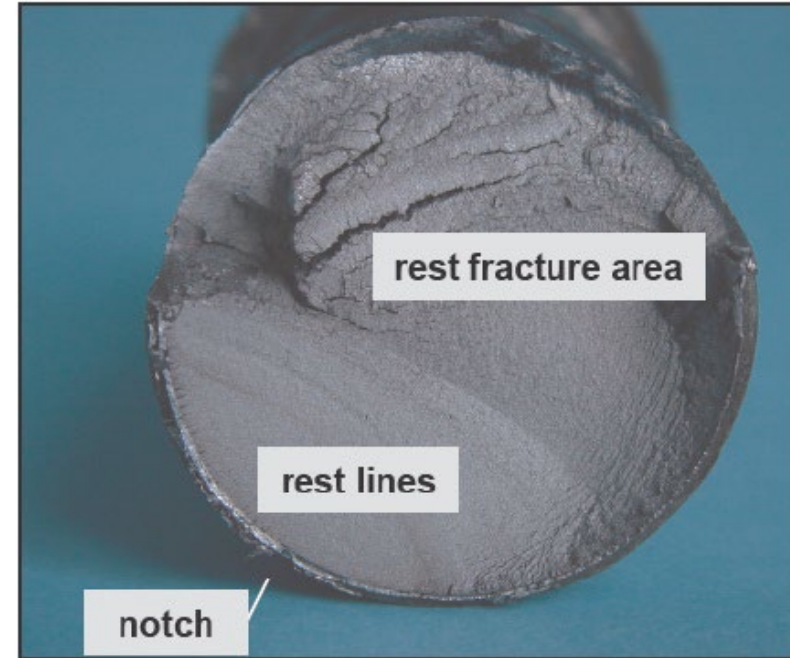
Fatigue failure

Initiation → Growth → Fracture

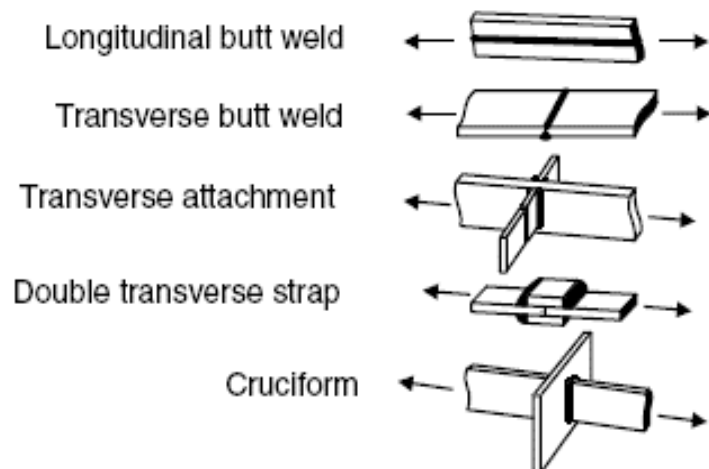
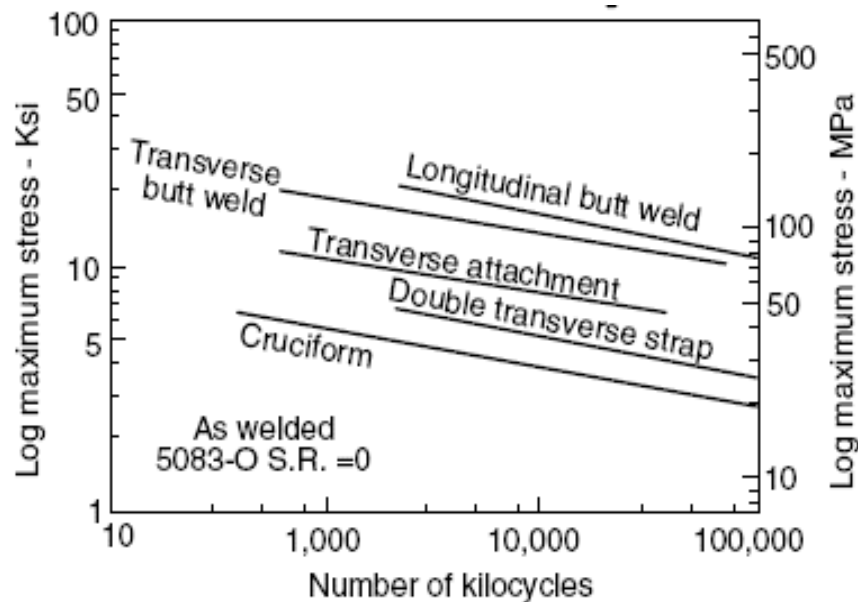
Joint configuration affects the fatigue life

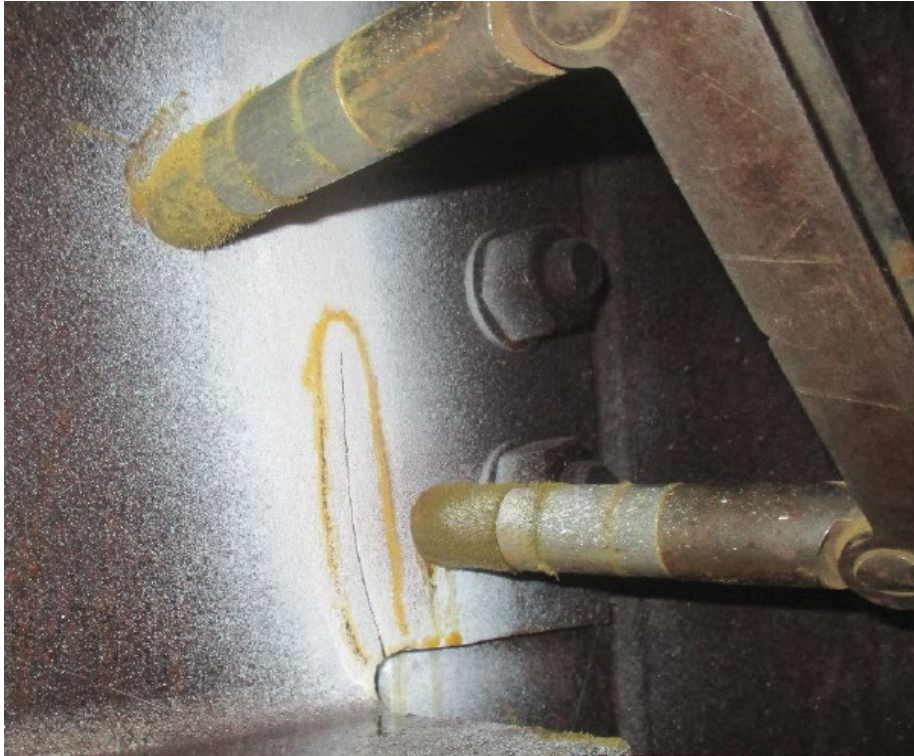
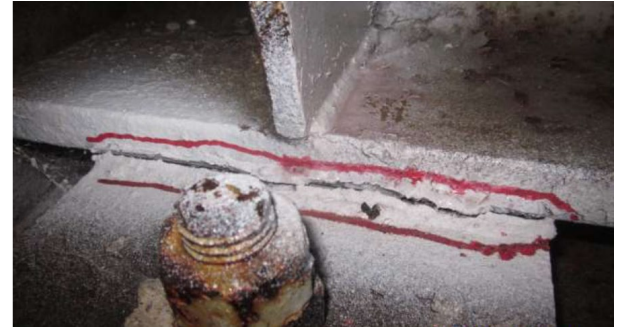
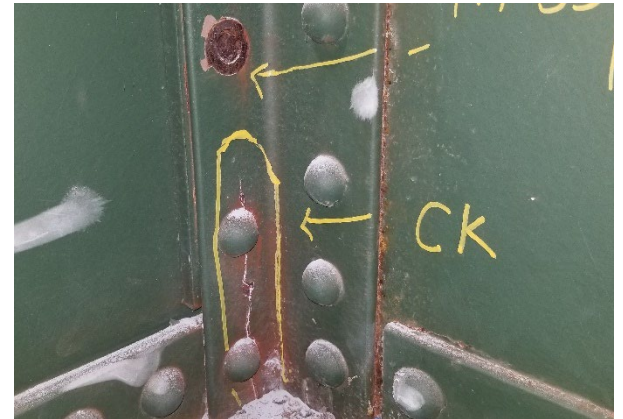
Fatigue cracks in steel bridges

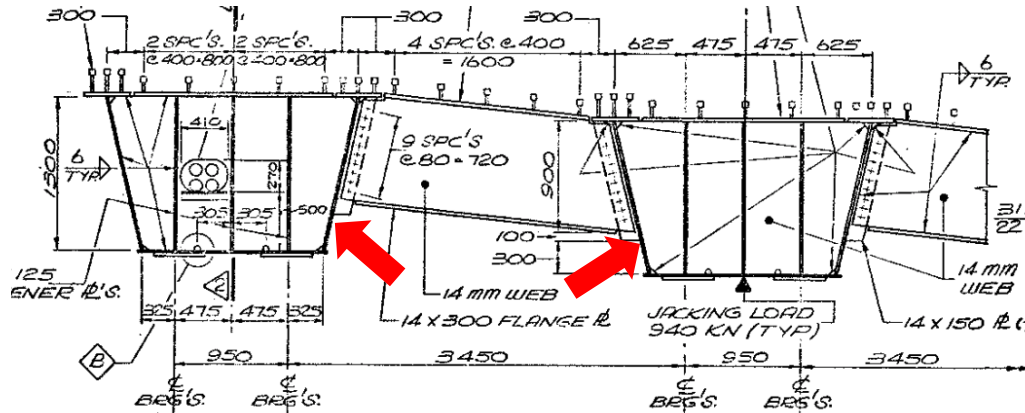
PART SECTION AT ABUTMENT DIAPHRAGMS

Distortion induced fatigue details

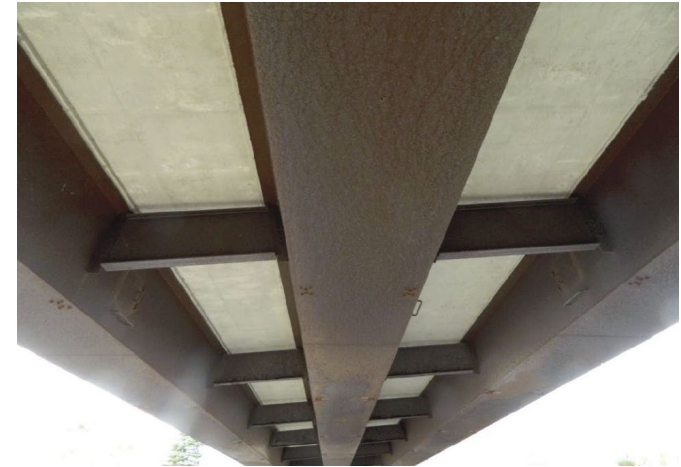
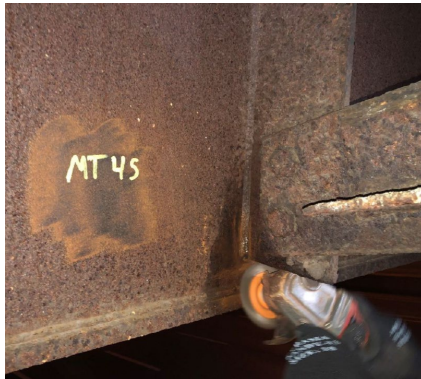
Updated design detail to eliminate the risk of fatigue cracking

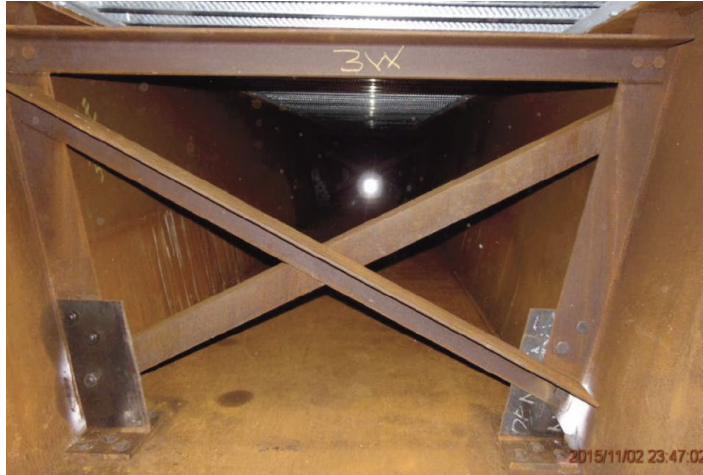
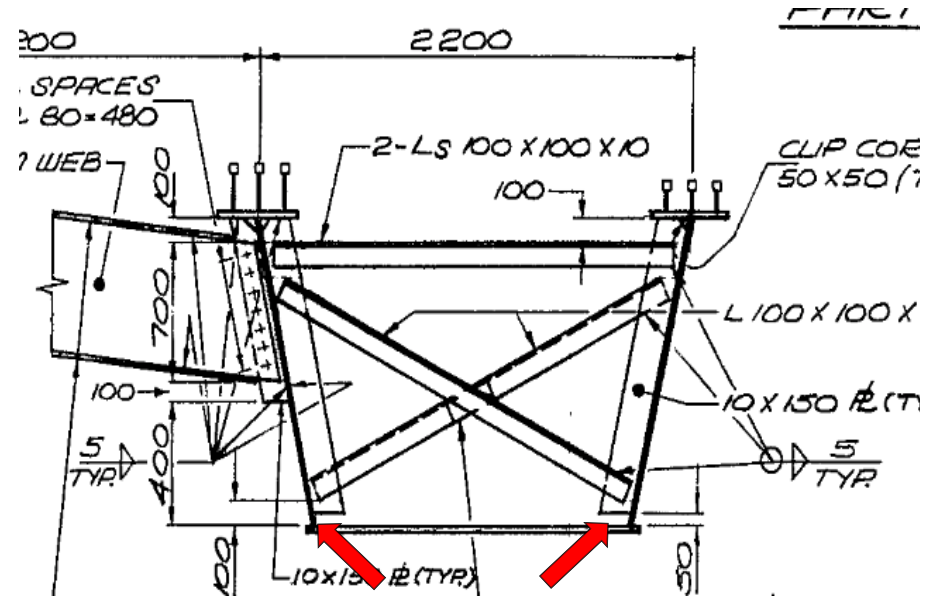
Distortion induced fatigue details

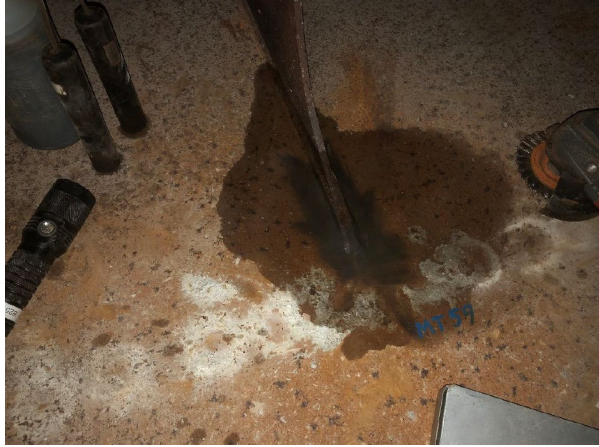
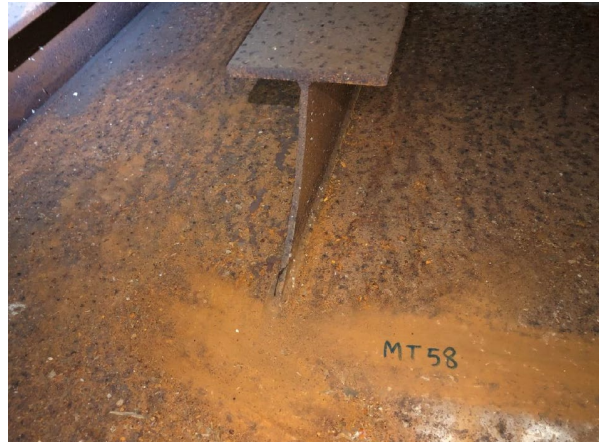
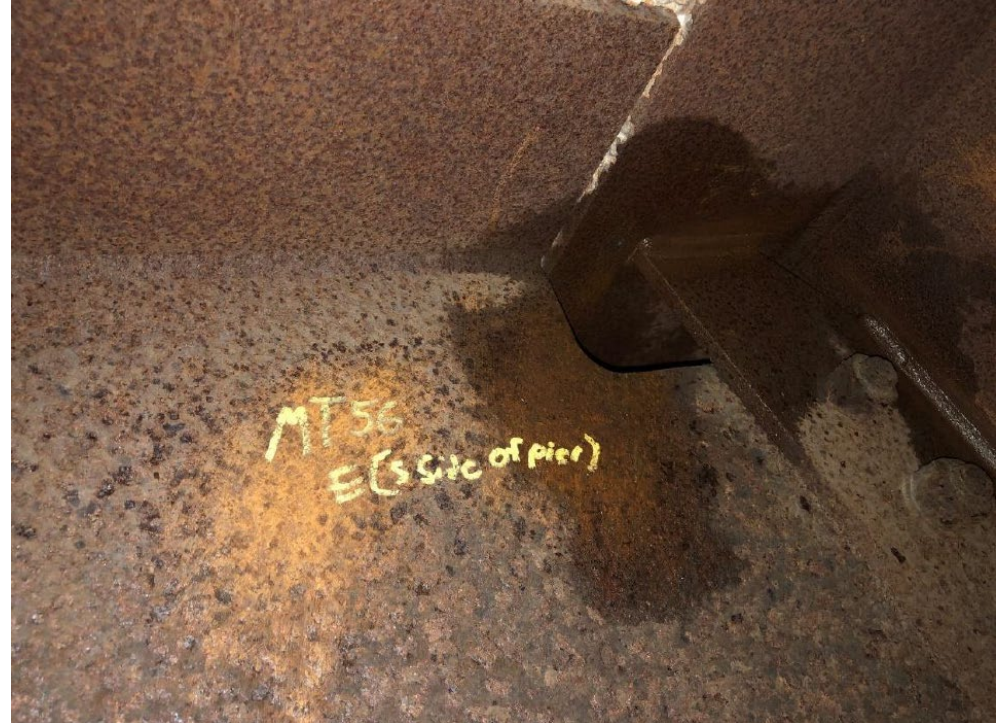
Fatigue prone details

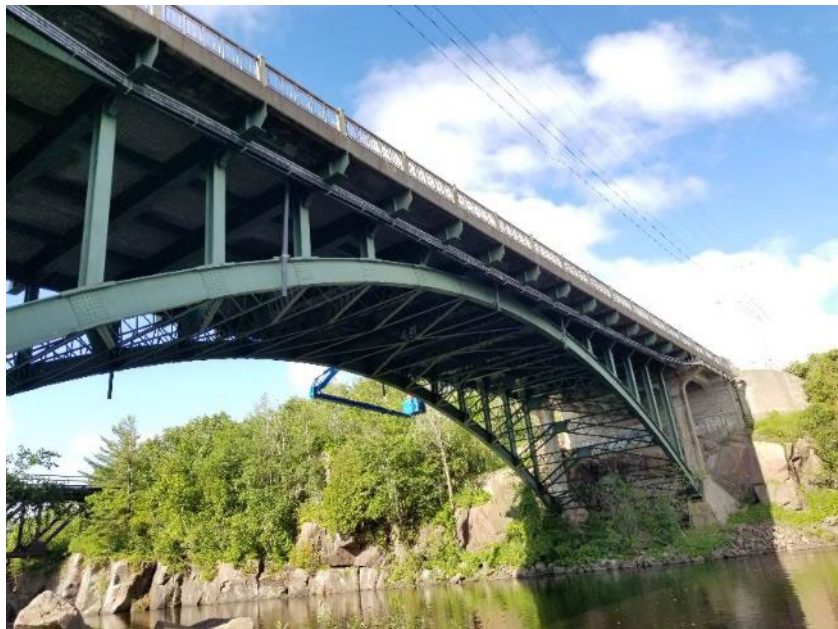
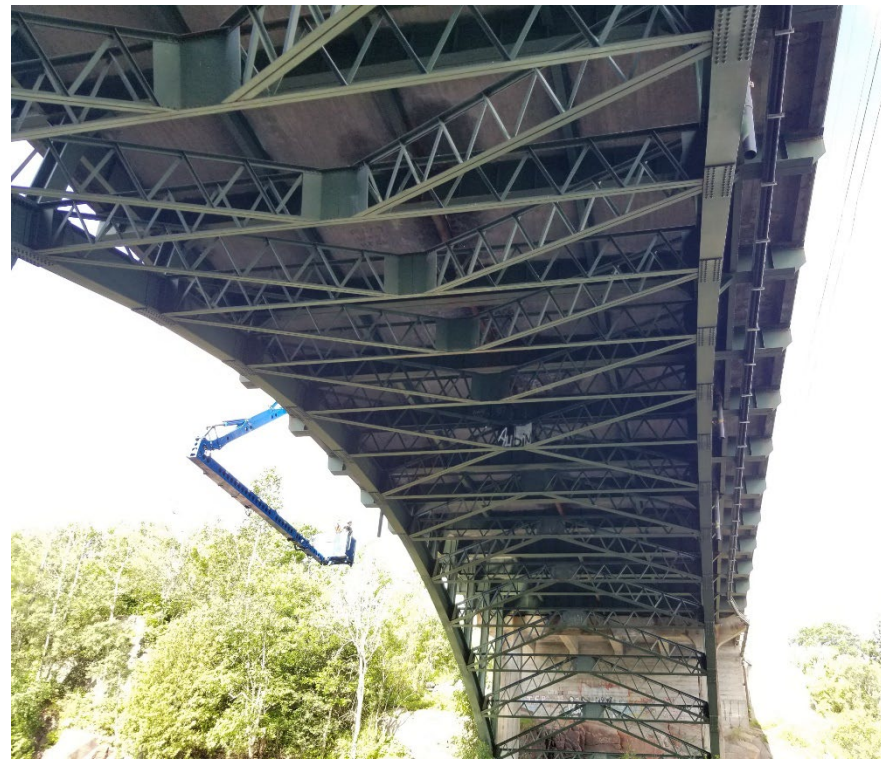
Aerial platforms

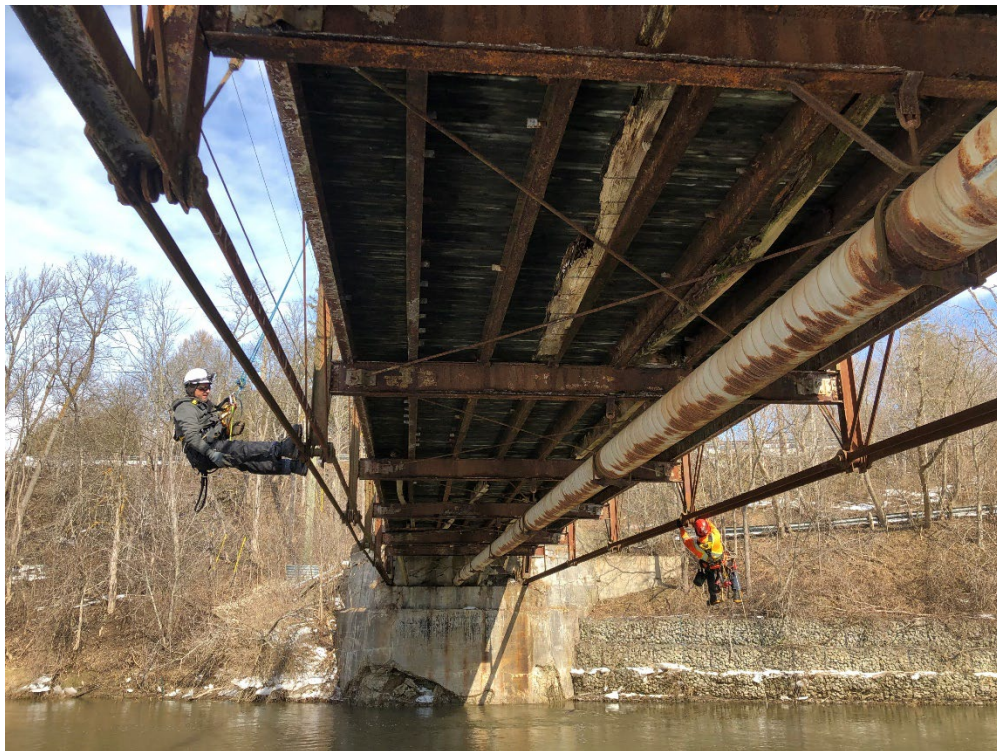
Bridge-master

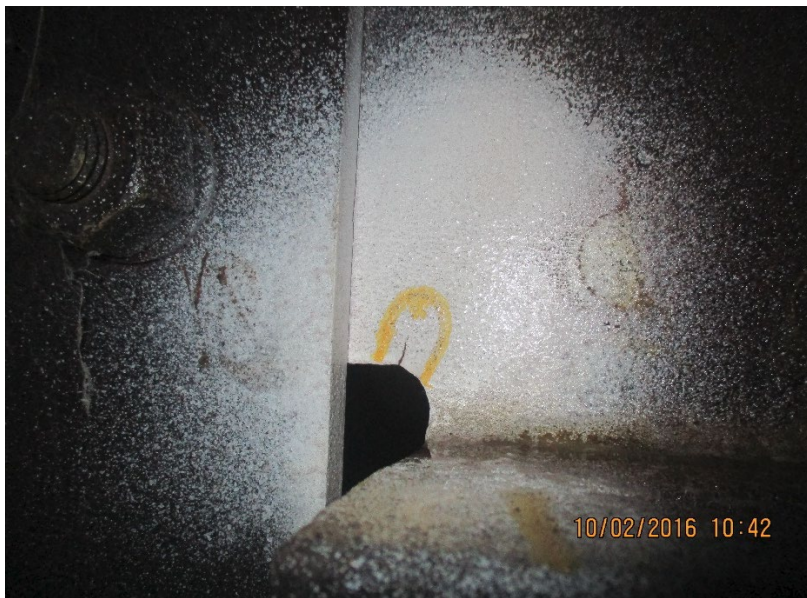
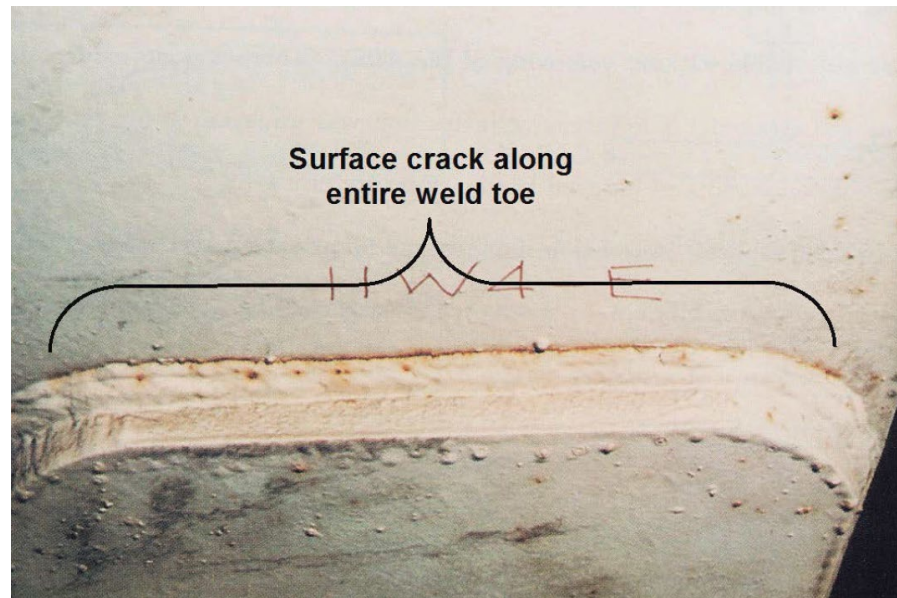
Fatigue cracks

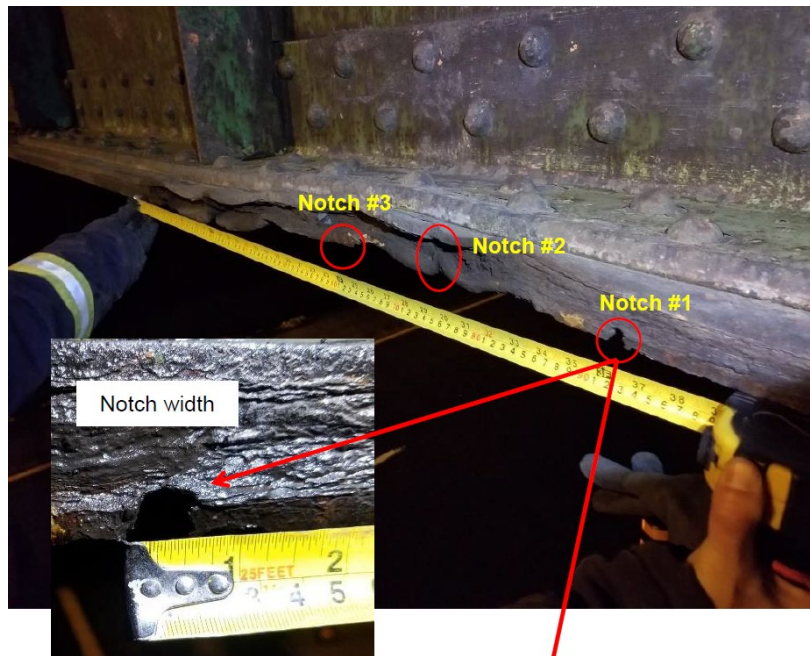
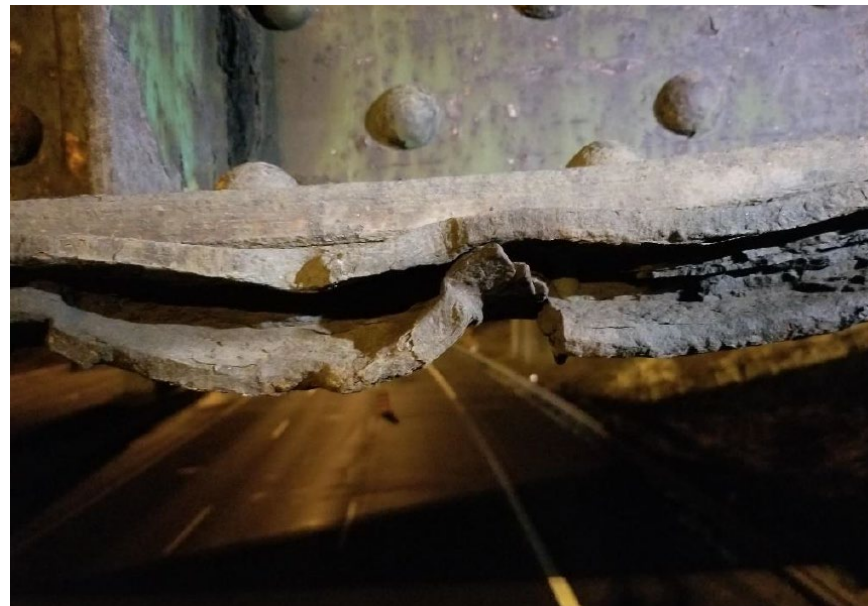
Impact damages by traffic

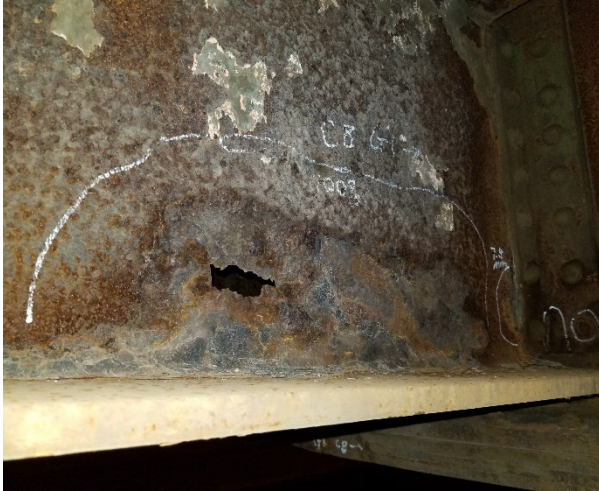
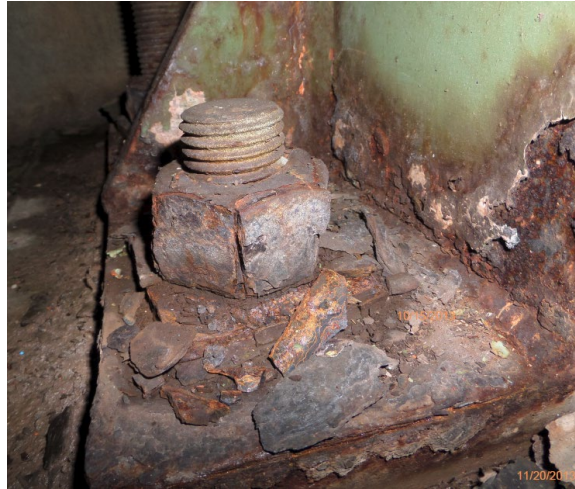
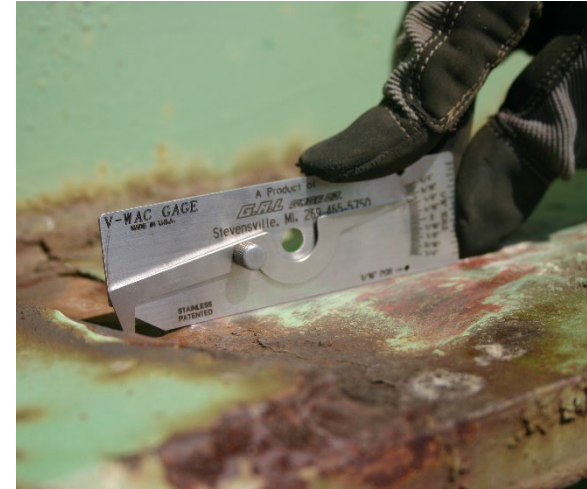
Corrosion
