NDT in Canada
NDT*i*C 2017
Canada's NDT Conference

NUCLEOM
INNOVATION • INTEGRATION

**Improved Surface Breaking Flaw Detection and
Characterization by Multi-Technique Automated Inspection**

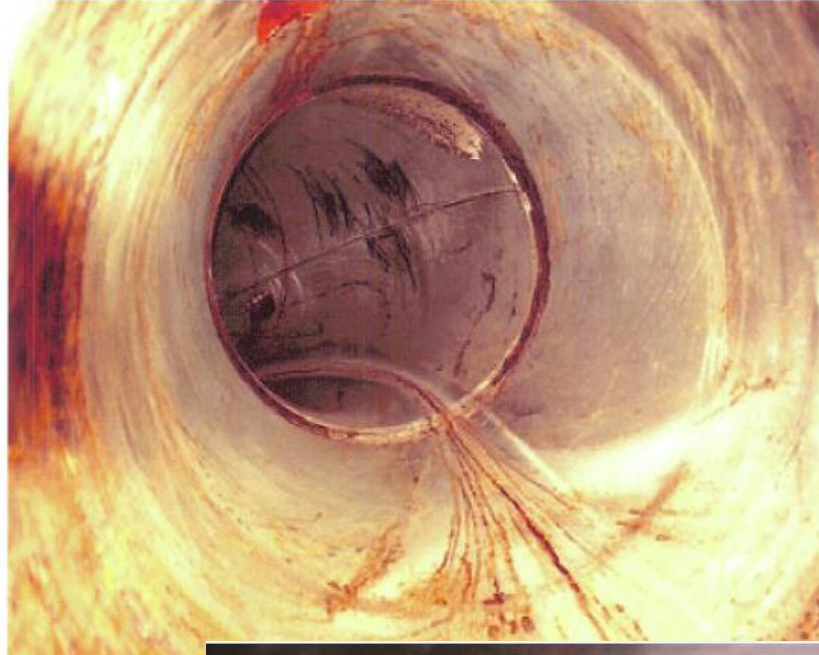
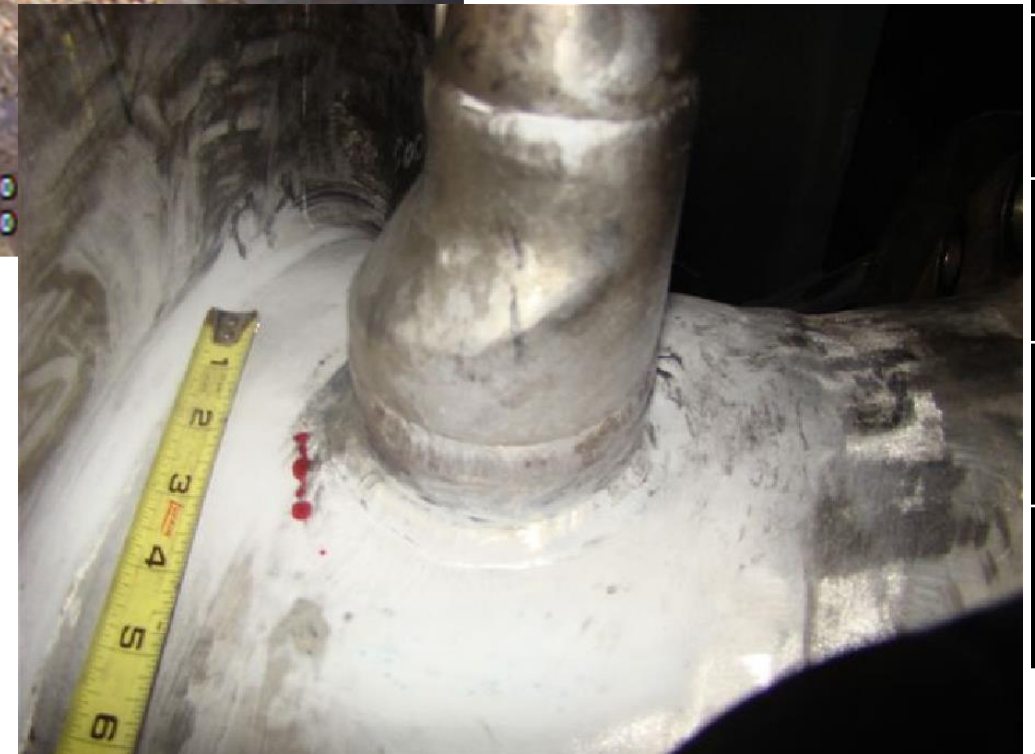
Previous Inspections

- Manual PAUT

- Omniscan MX 16/128 with a 5L64-A12 transducer on a SA1 45T Wedge
 - 5.0 MHz, 0.60mm pitch, 38.4mm active aperture
- Numerous linear indications were detected, largest NTW

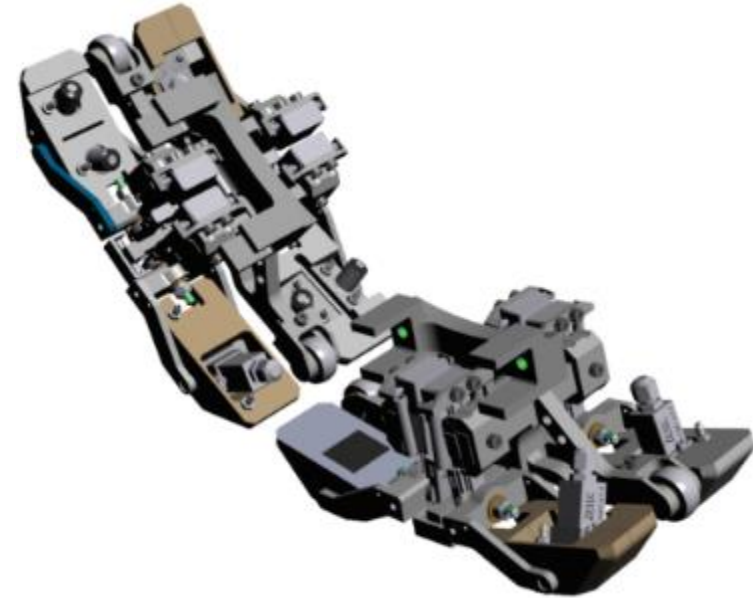
Eddy Current Array

- Orthogonal elements (10 in total)
- Drive frequency: 300 KHz and 500 KHz
- Axial coverage of a single pass: 15mm

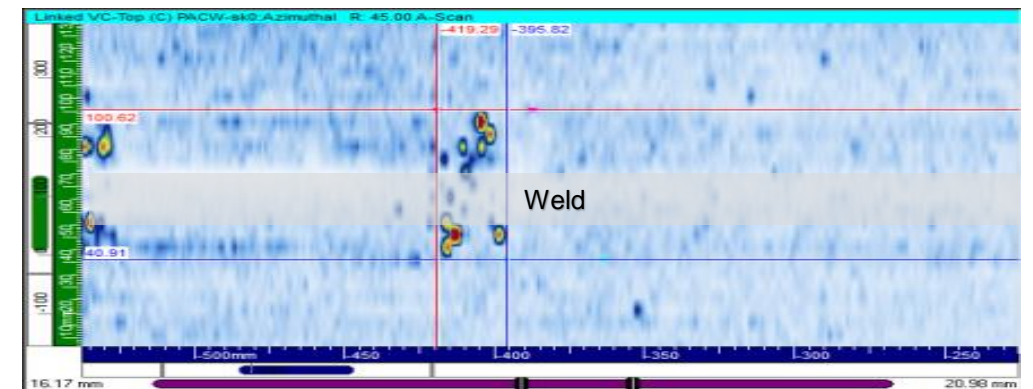
Simulated TGSCC (Straight Coupon):

- 100% Detection
- Both UT and ECA
