Phased array applied to the examination of the resistance spot weld process

A. OUELLETTE, A. M. CHERTOV AND R. GR. MAEV

NDT in Canada 2017 Conference (June 6-8, 2017)

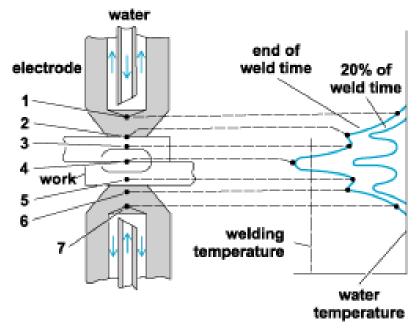
Resistance Welding Process

- Makes use of two or more plates clamped between copper electrodes
- Current is applied to heat the plates, with water cooling preventing overheating of electrodes

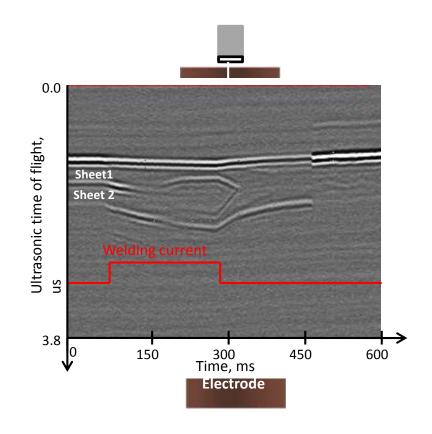
M-scan Formation

- During the acquisition process ultrasound is used to probe the process
- Repeating this at a rapid rate allows for the formation of an M-scan showing the evolution of the weld stack

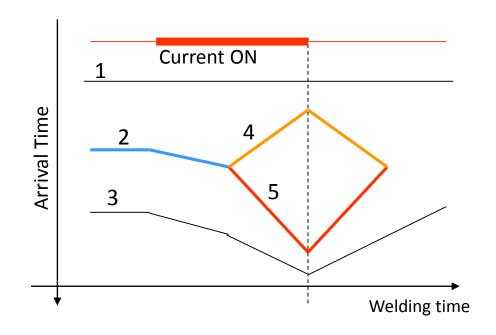
M-scan Processing

- The best indicator of a good weld is the evolution of the central reflection into two molten pool reflections during the current on (heating) period
- Upon cooling its absence of a boundary between the sheets can be indicative of a bond

- 1 Copper-steel reflection between cap and workpiece
- 2 Reflection from between workpieces
- 3 Reflection between workpiece and opposite cap
- 4 Top of molten steel pool
- 5 Bottom of molten steel pool

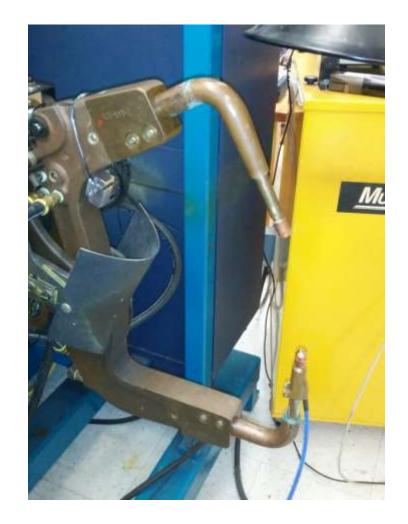
X-gun Arrangement

- X-gun arrangements make use of a scissor like motion to secure the workpiece during welding.
- During welding, resurfacing of the caps and variations between parts results in a misalignment occurring with respect to the workpiece

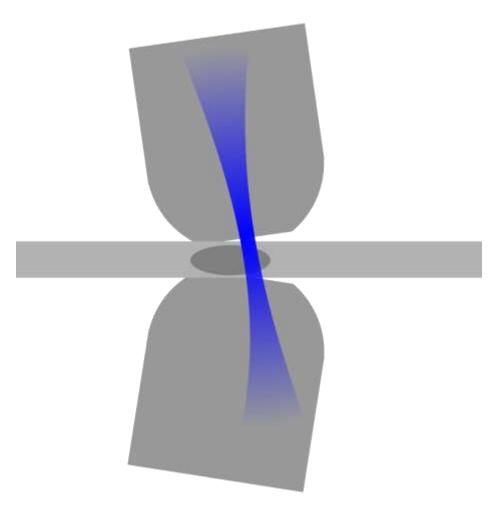
X-gun Arrangement

This misalignment does not severely degrade weld quality, but can make monitoring difficult when it becomes greater than a few degrees

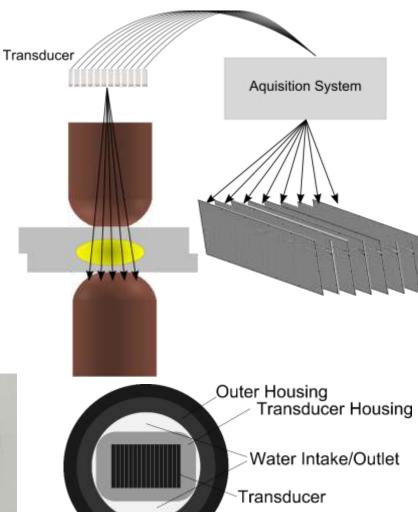
Phased Array Monitoring

- With this and other issues resulting from misalignment, a phased array implementation of the monitoring system was investigated
- This system allows for scanning along a single dimension, eliminating one degree of misalignment

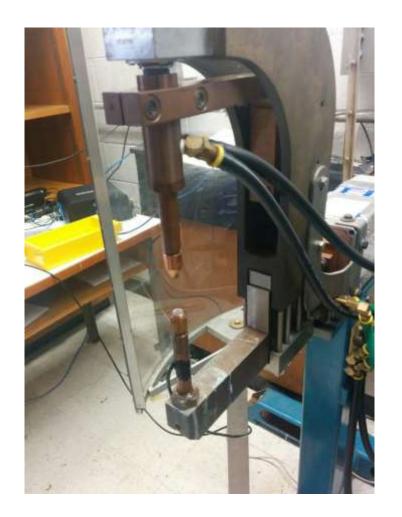
C-gun Arrangement

These experiments were conducted using a C-gun arrangement

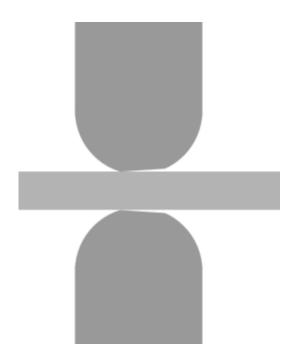
C-gun Arrangement

Misalignment was simulated by polishing weld caps at small angle, introducing

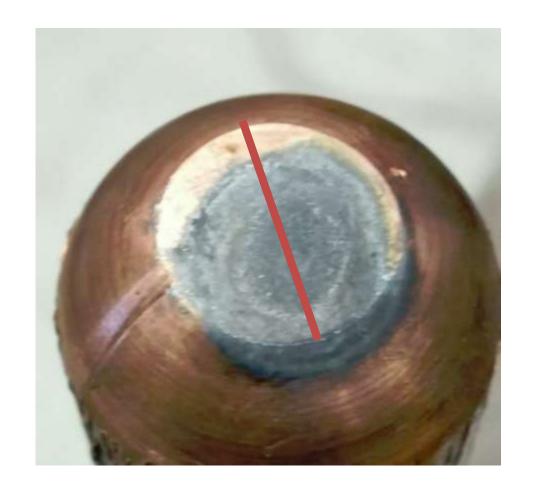
Generating misalignment

- This results in a weld offset from the center of the cap
- Imaging direction was adjusted to be along misalignment of system

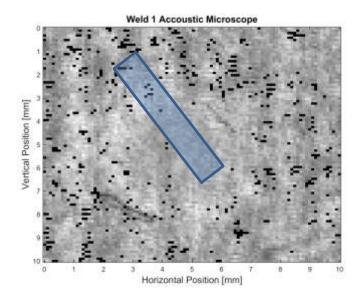
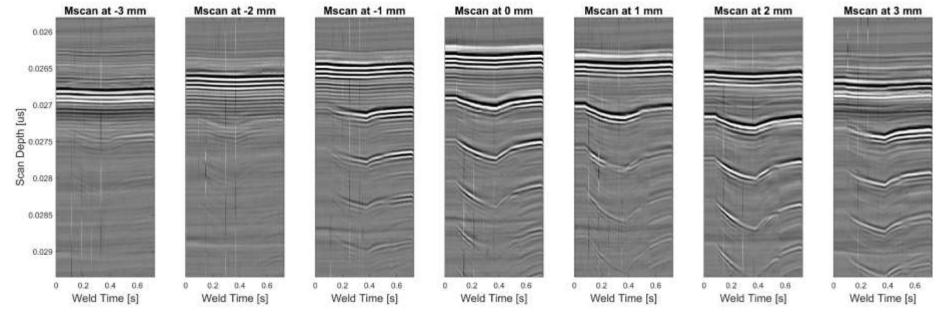
Clear reflections show no adhesion of any kind during the weld process

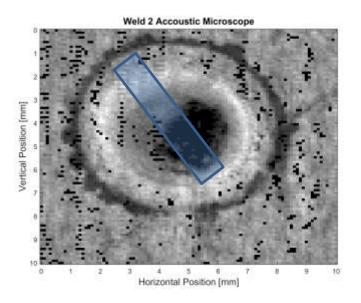
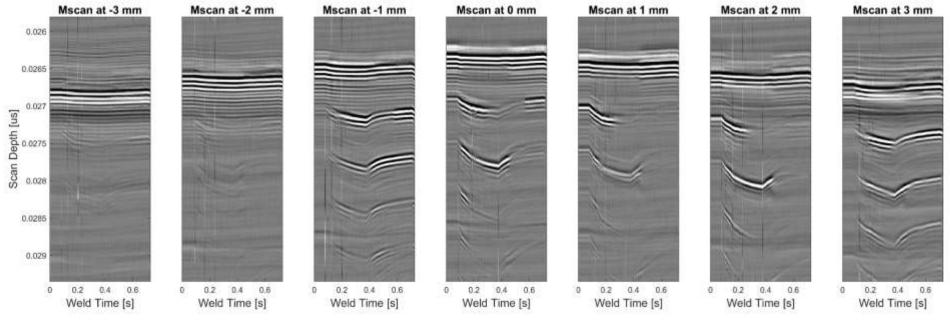
7000 A, 18 Cycles (0.3 s)

No Melting observed, boundary disappears

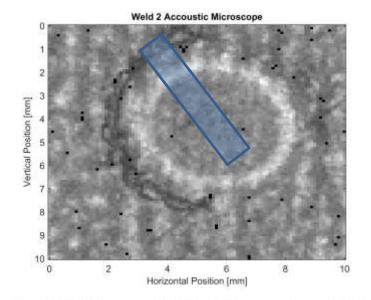
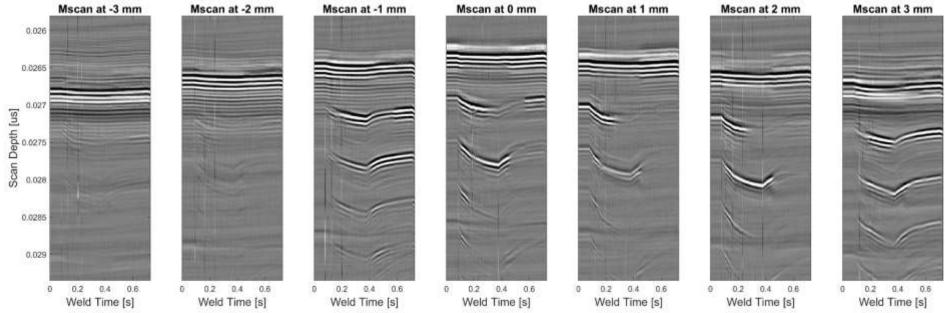
7000 A, 18 Cycles (0.3 s) *same weld as previous

Impact and subsequent scanning shows that bond formed by zinc layer, no weld present

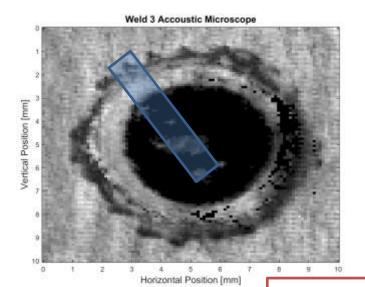
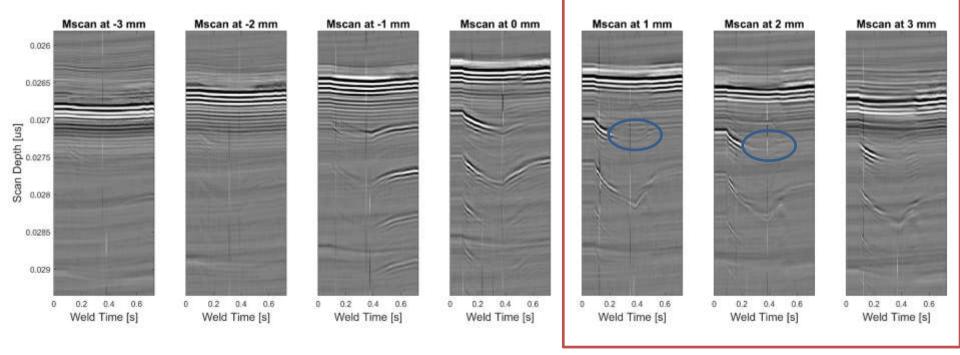
Melting observed, but interface is present during molten phase

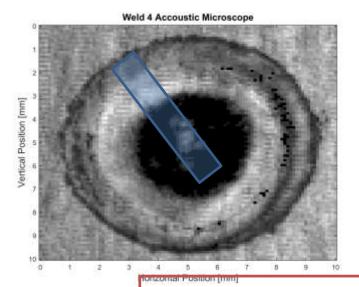
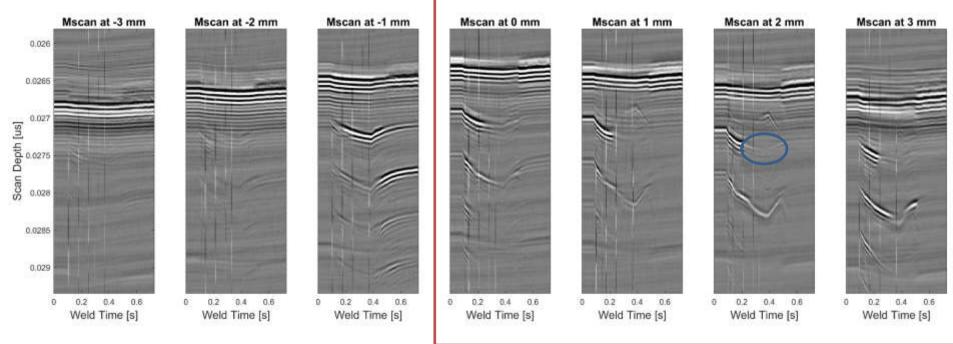
No Melting observed, boundary disappears. Possible void detection outlines in blue

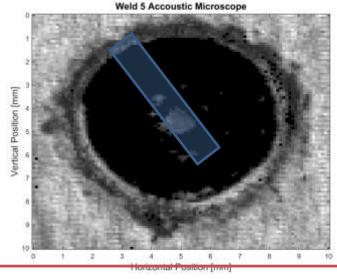
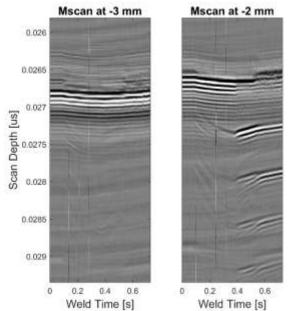
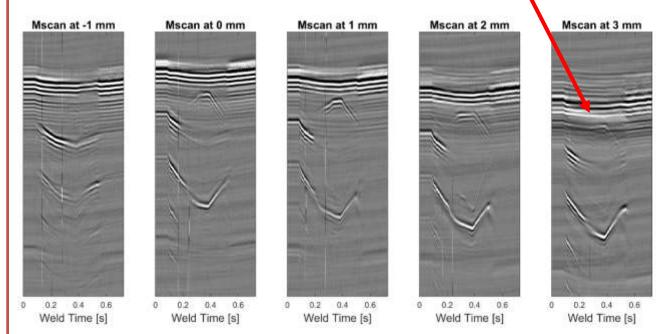
9000 A, 18 Cycles (0.3 s)

Large Weld nugget visible, Should extend further than view range

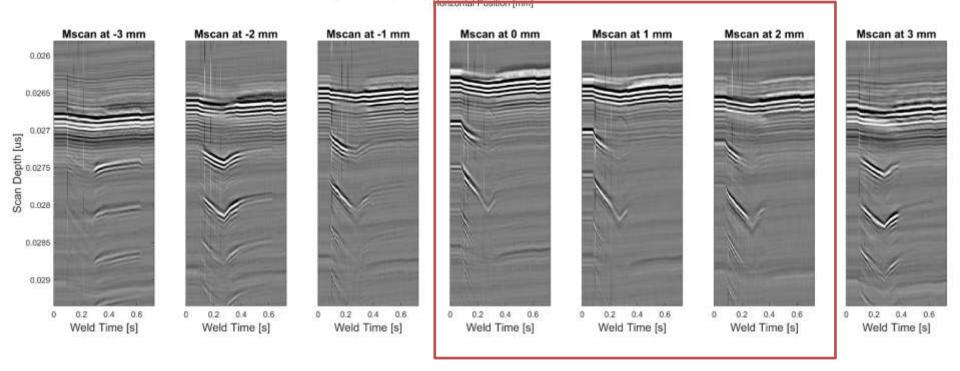
Weld appears much larger than predicted. Further investigation needed as to cause.

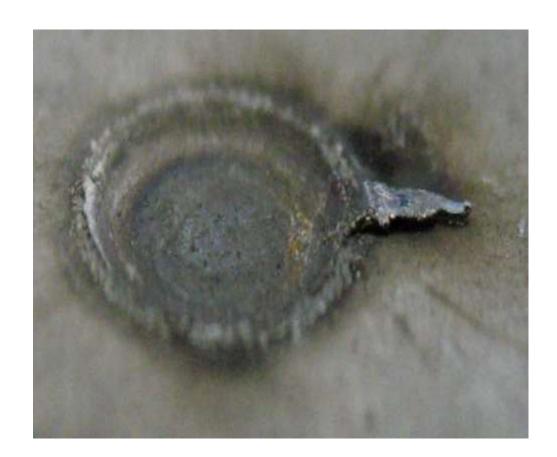
Expulsion from Weld Pool

During welding, if the cohesive force of the pool is disrupted or overcome molten metal is ejected from the weld

Depending on the amount or severity of expulsions the weld can be considered defective

Expulsion can occur from any of the interfaces during welding

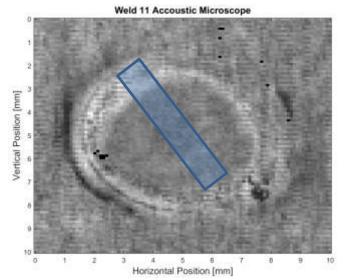
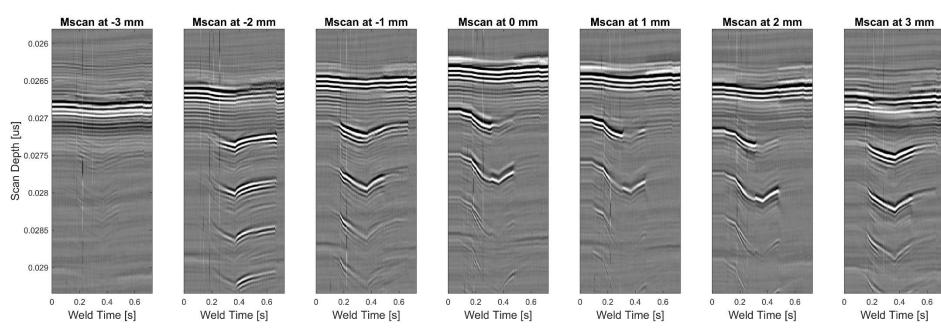
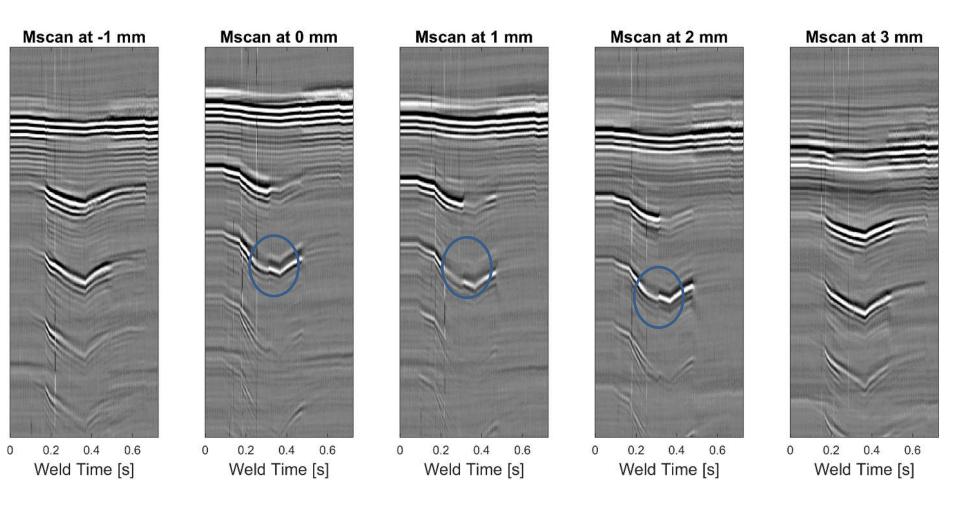
5000 A, 5 Cycles (0.08 s) 9000 A, 12 Cycles (0.2 s)

Expulsions identified by partial wave shifts between frames. Localization to the middle of weld
