Non-destructive evaluation of impact damage in carbon fibre reinforced polymer using infrared thermography and shearography

By: Ali Khademi Far, Martin Viens, Louis-Daniel Th roux, Olivier Ar s

NDT in Canada
NDT   **C** **2019**
Inform - Engage - Advance

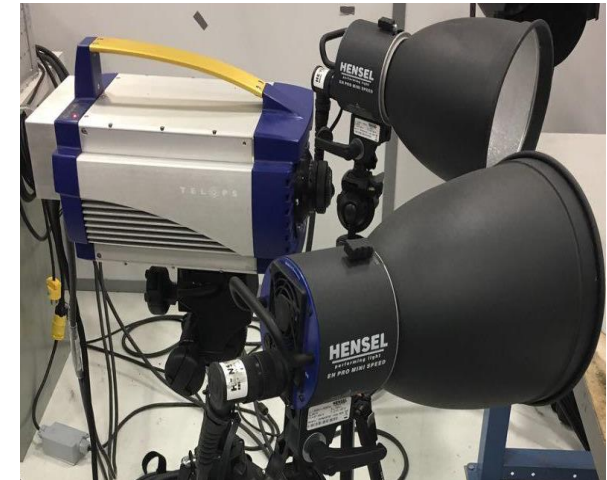
Thermography setup

- Telops cooled infrared camera 640 x 512 detectors
- Matlab and IR-view software
- Two 3 kJ Hensel flash lamps
