ASSESSMENT OF DAMAGE IN ROCK BOLTS USING ULTRASONIC GUIDED WAVE MODE CONVERSION

Serge A. KODJO, Ishak MEDFOUNI,
Patrice RIVARD, Kaveh SALEH, Marco
QUIRION

NDT in Canada
NDTⁱC 2017
Canada's NDT Conference

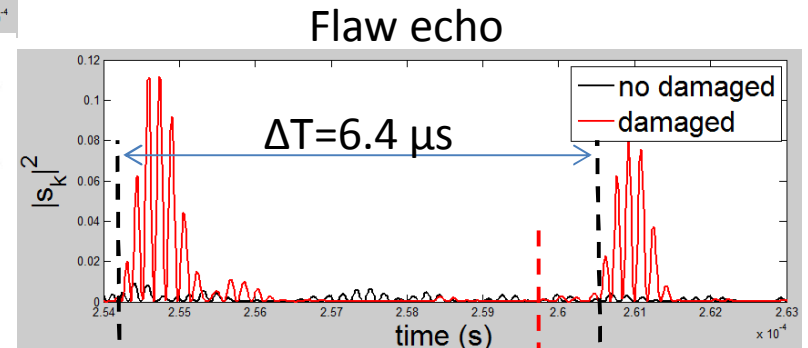
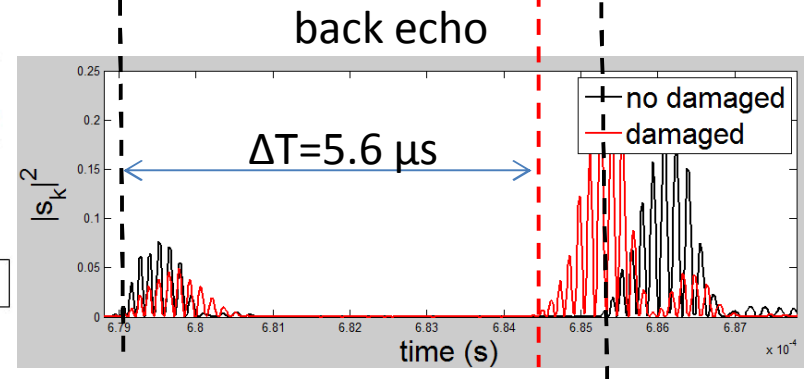
Zone 1: $d=25 \text{ mm}$ ((measured with vernier caliper) $d=24 \text{ mm}$ (estimated by US pulse echo)

Zone 2: $d=21 \text{ mm}$ (measured with vernier caliper) $d=21 \text{ mm}$ (estimated by US pulse echo)

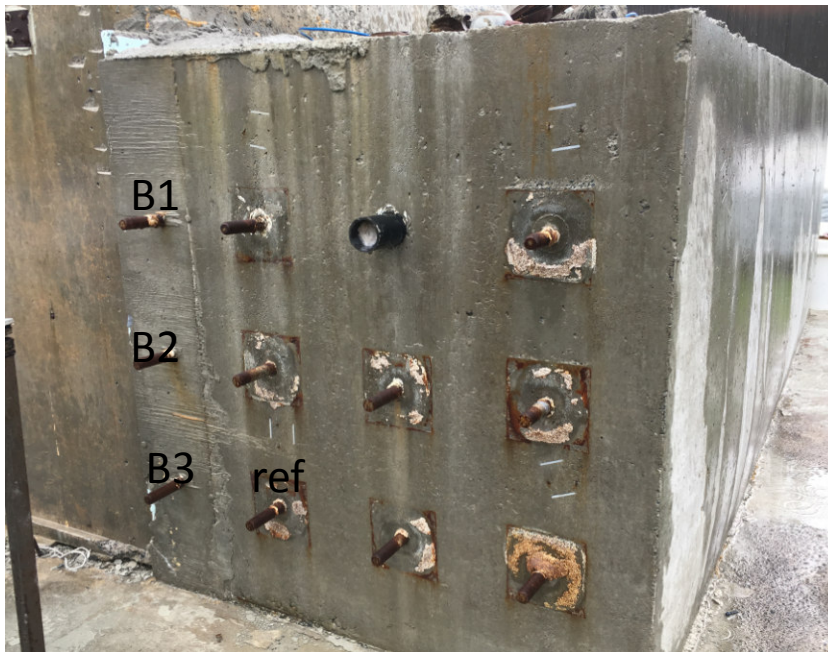
Rock bolts	d0 (mm)	d1 (mm)	l (m)	l_flaw (mm)
B1	25	21	3.5	60
B2	25	21	3.5	60
B3	25	21	3.5	60
reference	25	no flaw	3.5	no flaw

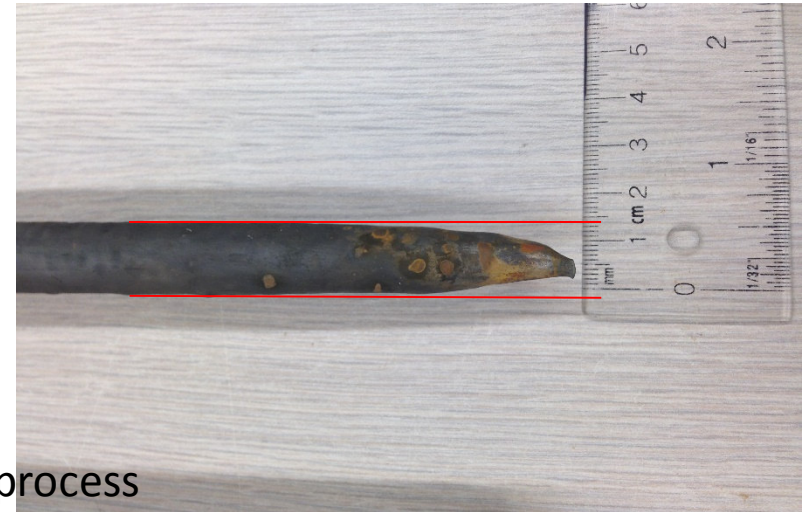
Uniform corrosion

Evaluation of section loss during accelerated corrosion process

Number of days	Estimated diameter (by pulse echo) (mm)	Measured diameter (mm)
Day 0 (0H)	25	25
Day1 (24h)	24.5	-
Day2 (48H)	24.5	-
Day3 (96H)	21	20
Day4 (144H)	9,8-17	4,3-16

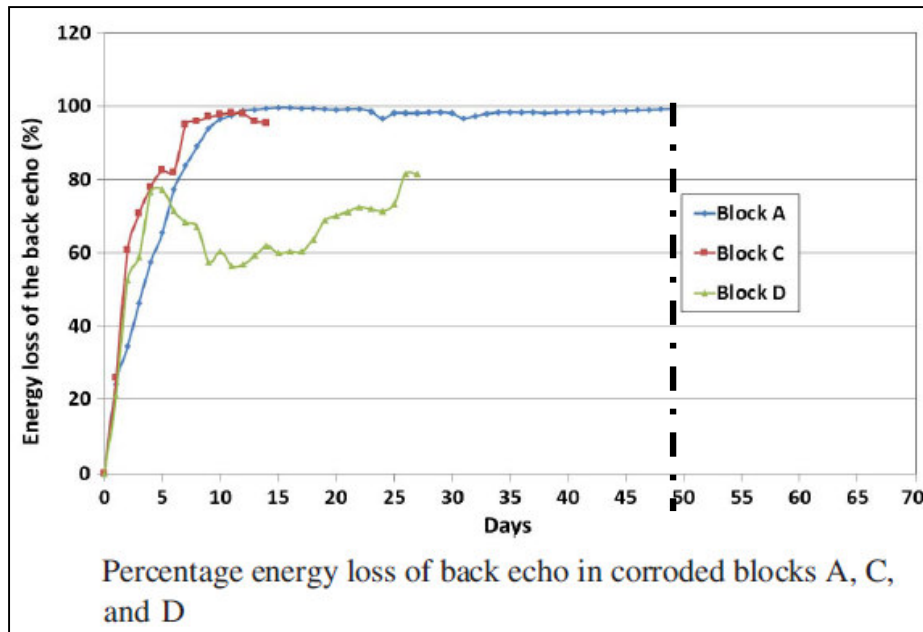
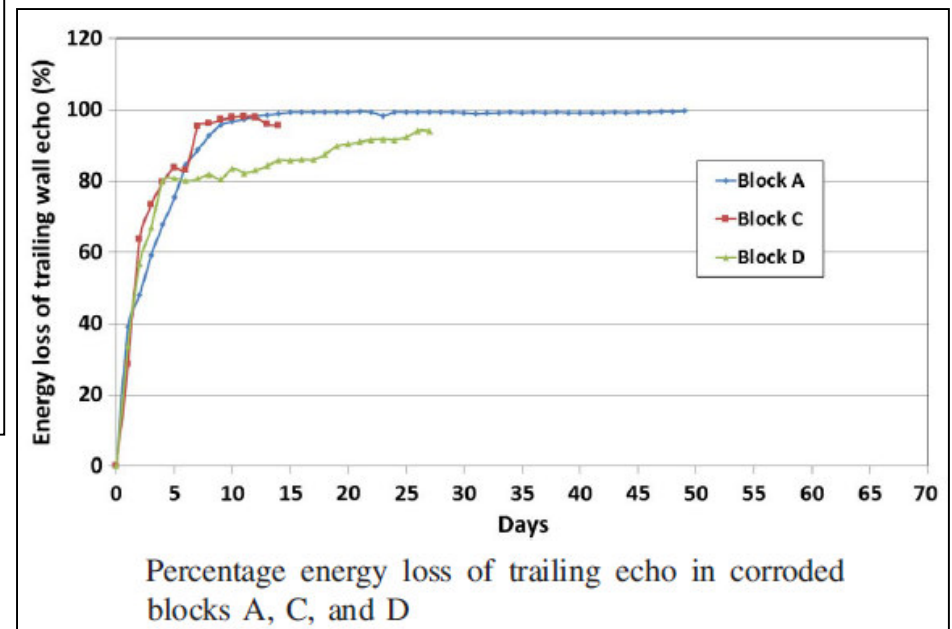
3 Blocks A, C, D submitted to accelerated corrosion

Length rock bolt =1 m

Pulse echo energy loss during corrosion process

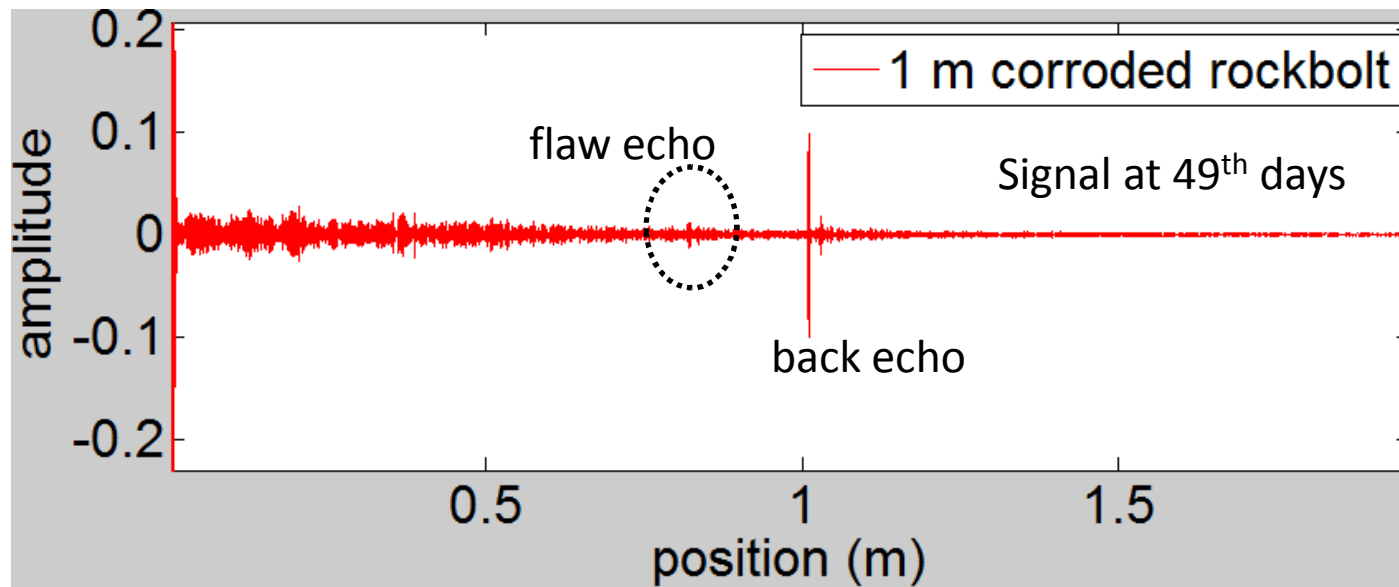
Localization of the flaw position

Position = (velocity x time)/2
