# Advanced Ultrasonic Alternatives for Inspecting Coarse Grained Stainless Steel Components

Mike Wechsler  
Technical Director, MISTRAS Group, Inc.

NDT in Canada  
**NDT*i*C 2019**  
*Inform - Engage - Advance*

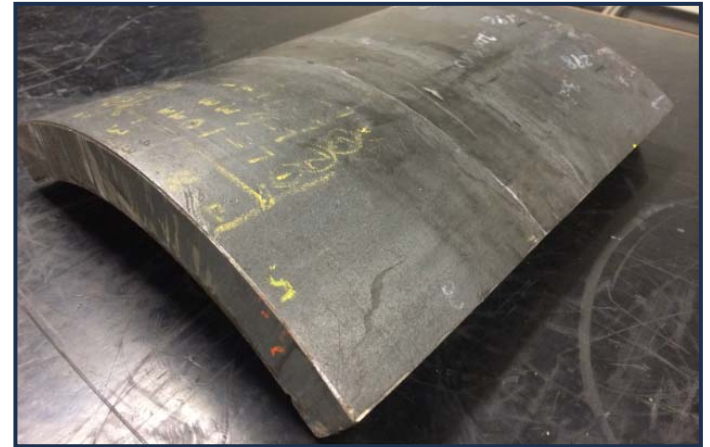
*Sampling of similar thickness/material calibration block revealed:*

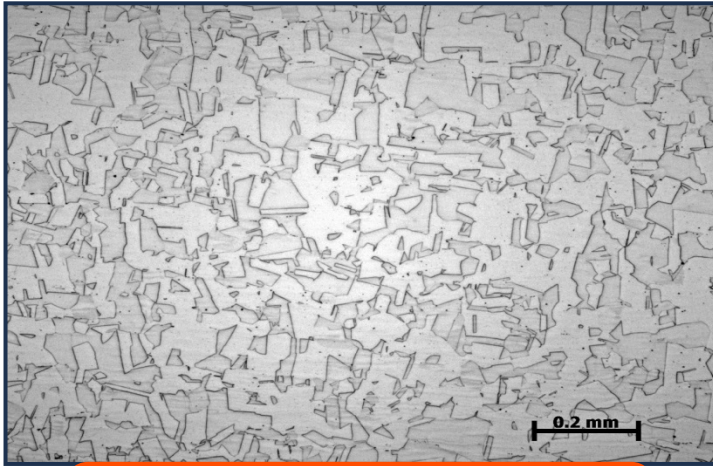
Typical 304SS Grain Size

**Microstructural Analysis revealed that grain sizes were off the microscopic grain chart in ASTM E112.**

**It is believed that this was due to extreme temperatures (2000 -2200 F°).**

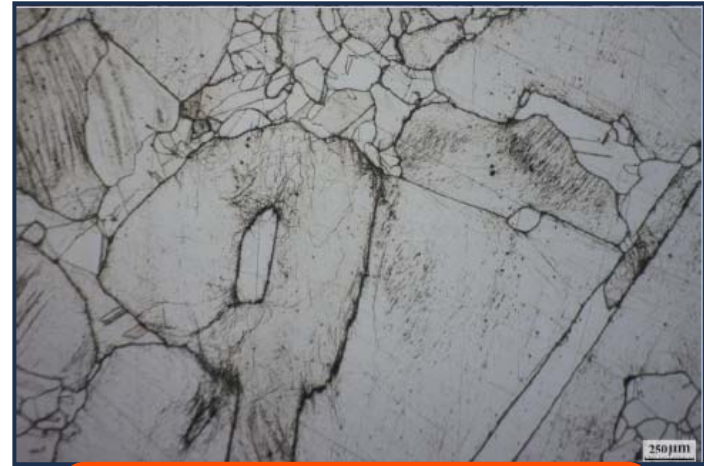
Typical 304SS Grain Size

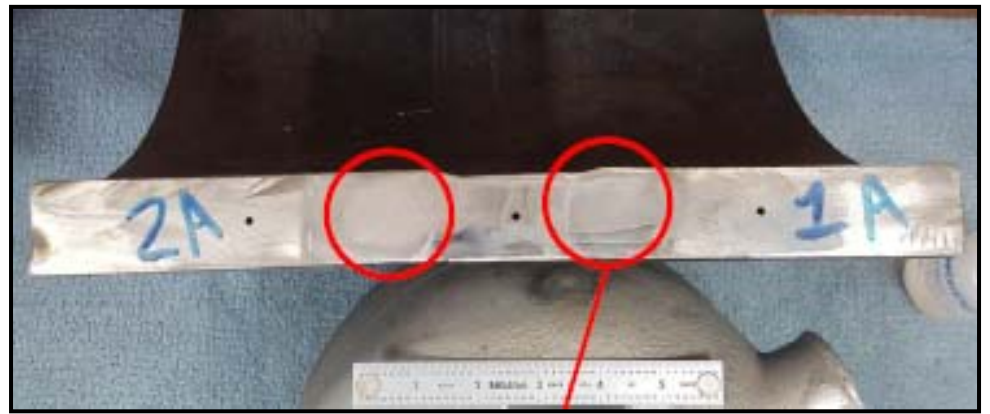
Grain Size is actually visible to the NAKED EYE!

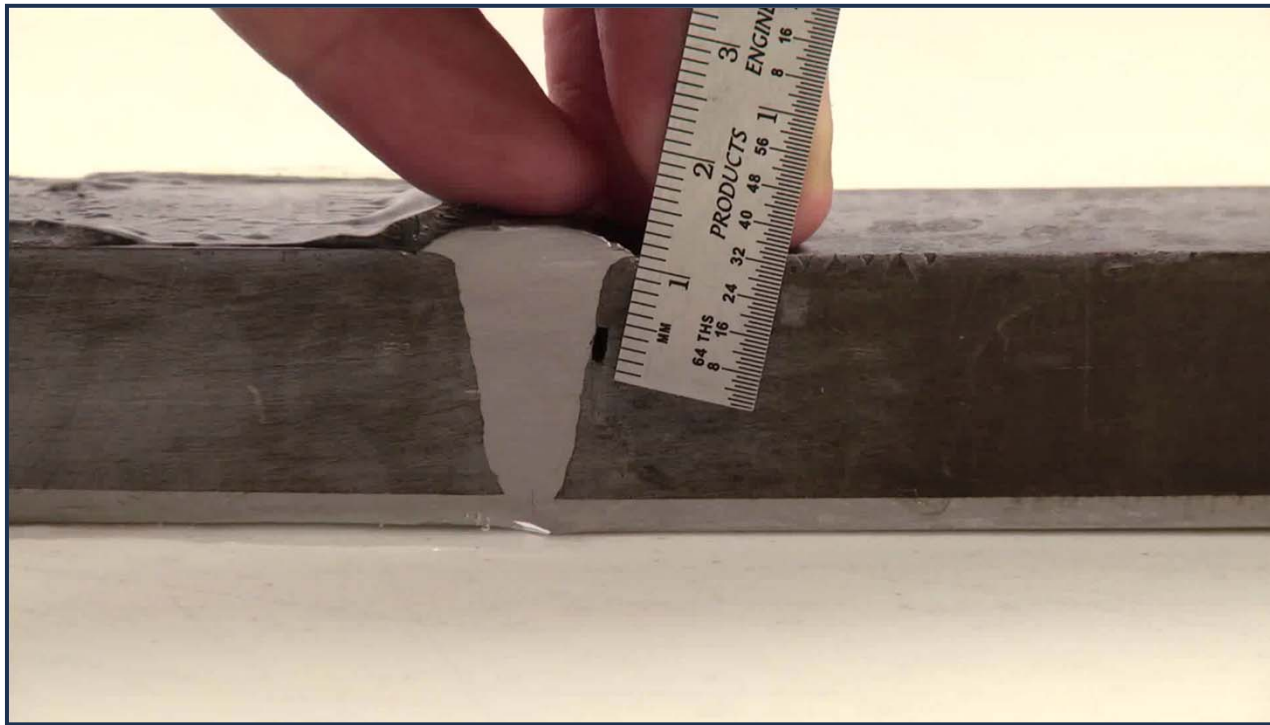
**DMA's versus Shear wave on large coarse grain materials**
