# Evaluation and Protection of Industrial Structures and Systems by NDT

Wai Lai (Winnie) Ying, Brycklin  
Wilson, Peter Szyplinski and Afshin  
Sadri

# Concrete Degradation Inspection

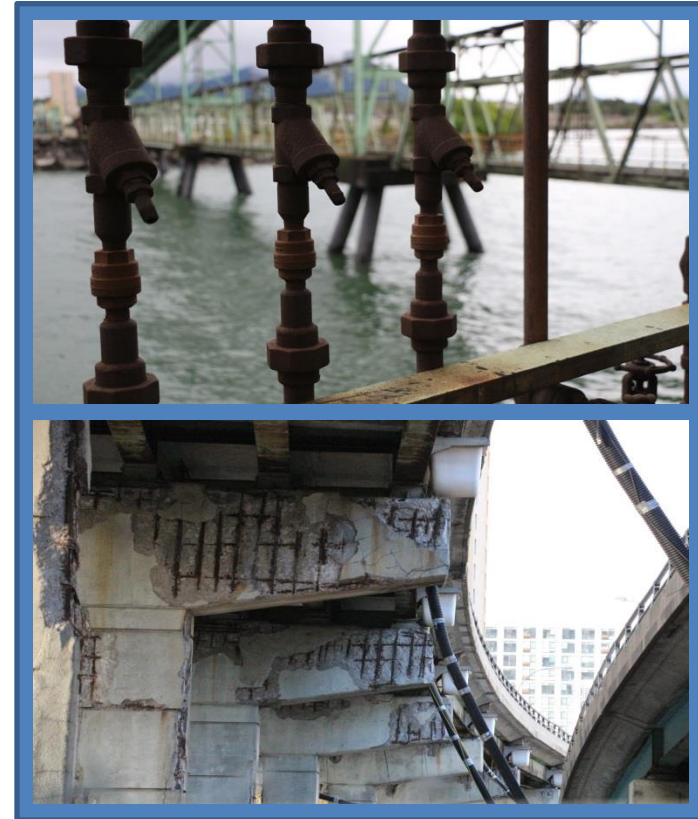
- Global cost of corrosion 2.5 trillion USD (3.4% of the global GDP)
  - This accounts for only direct costs as a result of corrosion
  - Production losses, downtime, environmental risks are additional cost
- Corrosion control and mitigation practices can save up to 35% of this (875 billion USD globally)

NACE IMPACT Study (2016)  
International Measures of Prevention, Application, and Economics of Corrosion Technologies

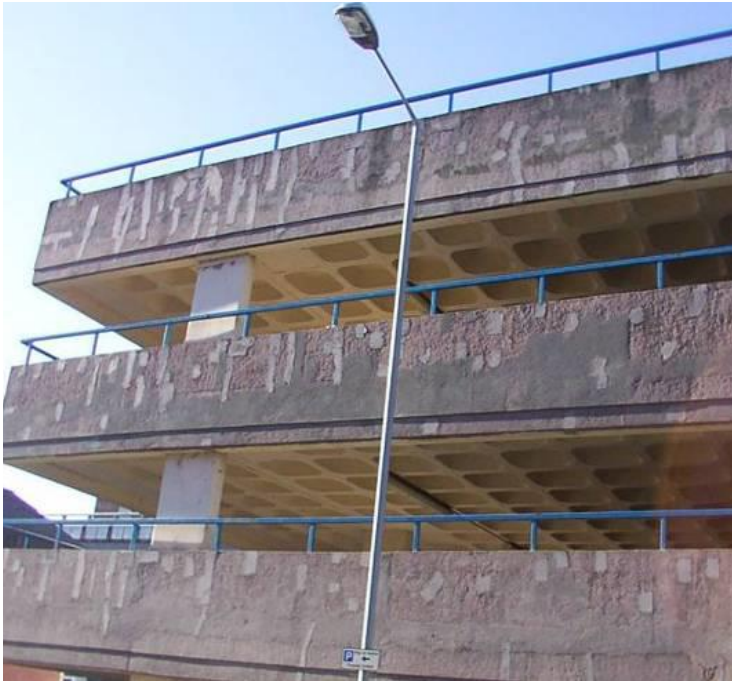
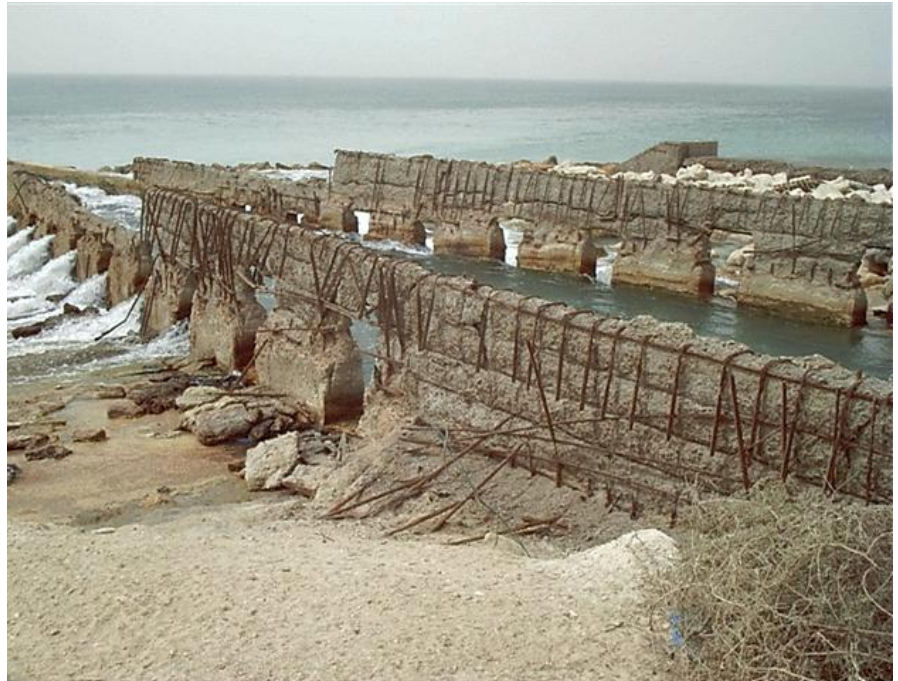
- Protective surface film due to the natural alkalinity of concrete.
- Aggressive exposures to sulphates and chlorides lead to spalling and delamination of concrete

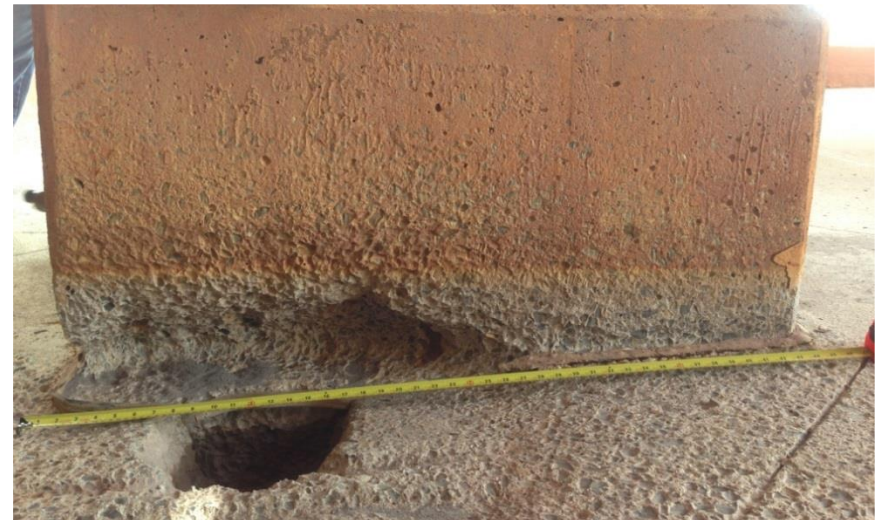
- Due to CAPEX restraints the client did not install acid resistant coatings or design drainage for acid solution.
- Warm acid solution drain over the concrete floor.
- Loss of concrete and rebar in the supporting concrete piers.

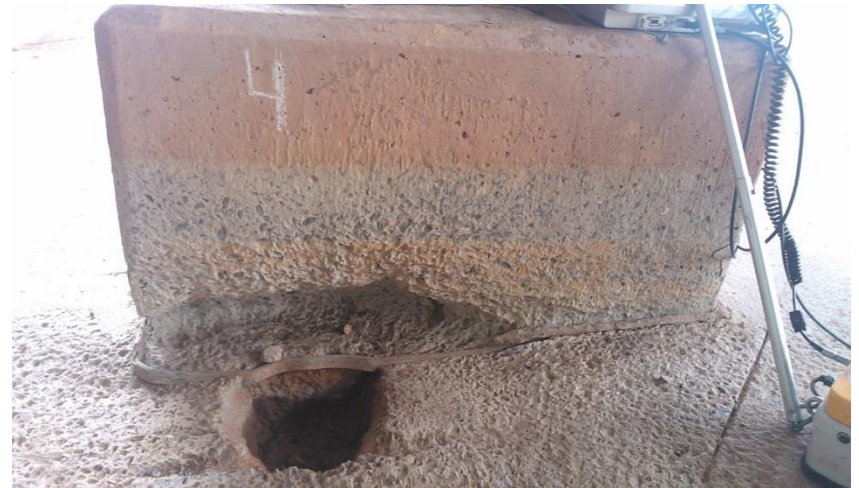
- Impact Echo
- Couplant required
- Calibration on site
- Concrete velocity differed by 6%
- Total reflection of signals due to major separation or delamination within the pier
- Partial reflection due to cracks and voids

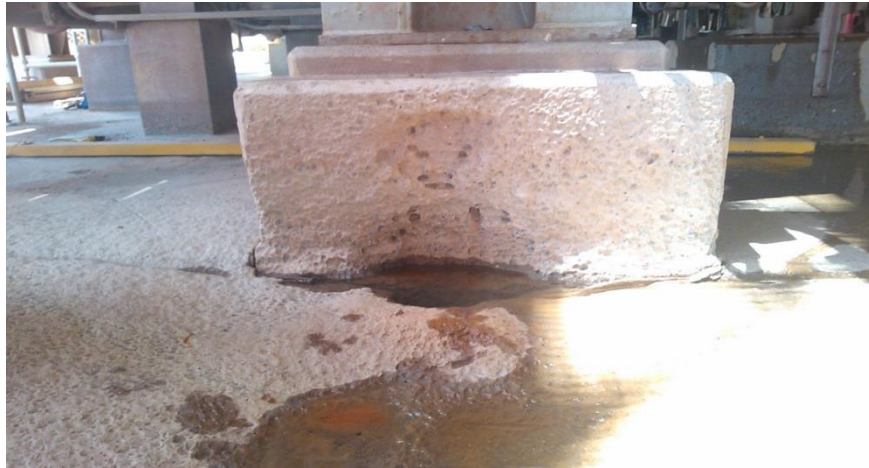
Pier C3

West Face			South Face			East Face			North Face		
NW		SW			SE			NE		NW	
18	17	16	15	14	13	12	11	10	9	8	7
30	29	28	27	26	25	24	23	22	21	<del>19</del>	<del>19</del>

West Face			South Face			East Face			North Face		
NW		SW			SE			NE		NW	
18	17	16	15	14	13	12	11	10	9	8	7
30	29	28	27	<del>26</del>	<del>25</del>	24	23	22	21	20	19

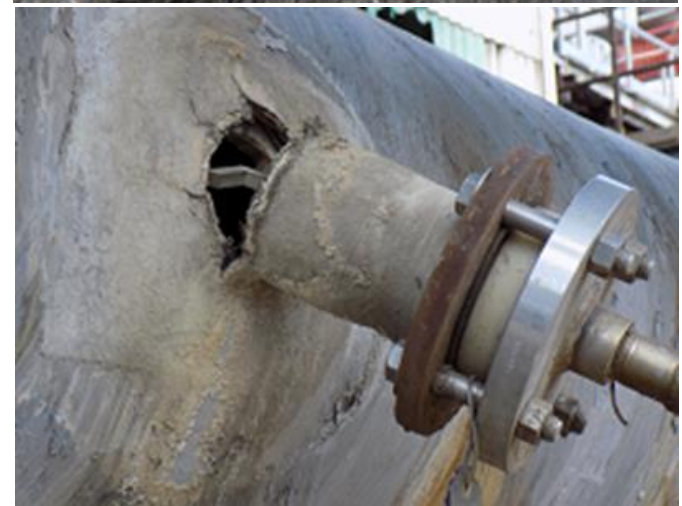
- Initial visual inspection to determine limitations to inspections.
- Top: Degradation due to weathering and UV exposure. The loose fibreglass filaments become airborne during surface preparation.
- Bottom: Broken nozzle of the fire-suppression system on a SO<sub>2</sub> line.

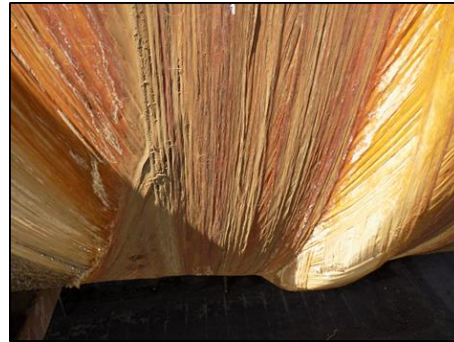
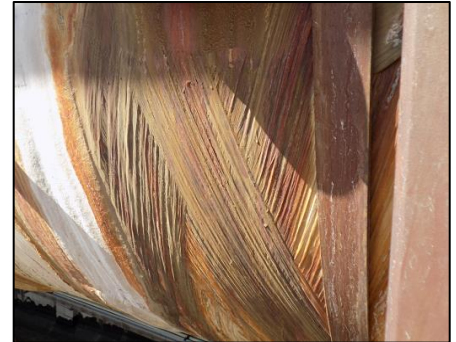
- Hand-made fibreglass ducts vs. factory manufactured
- Uneven initial wall thicknesses, poorly bonded layers, and excess/insufficient epoxy
