# Three Rivers Fountain

## Computer Radiography of The Murray Statue

April 2017

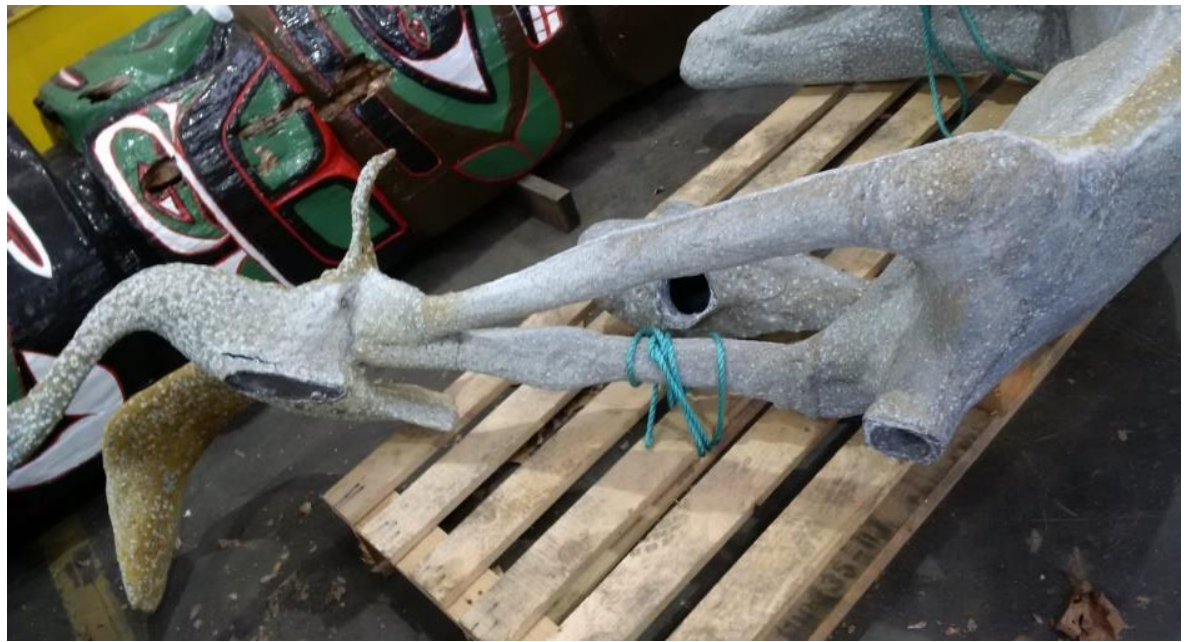
# Preliminary Evaluation

- Mountings failed requiring repair for re-mounting onto granite base. Impact damage resulted in numerous sections dismembered.
- Porous surfaces are not suitable for penetrant test due to residue & permanent staining.
- Cast aluminium is severely pitted with significant wall loss visually evident.
- Cast Statue with welded sections, weld zones are weathered to an even surface appearance.
- Visual evidence of cracking at some critical points– joining of arms etc.

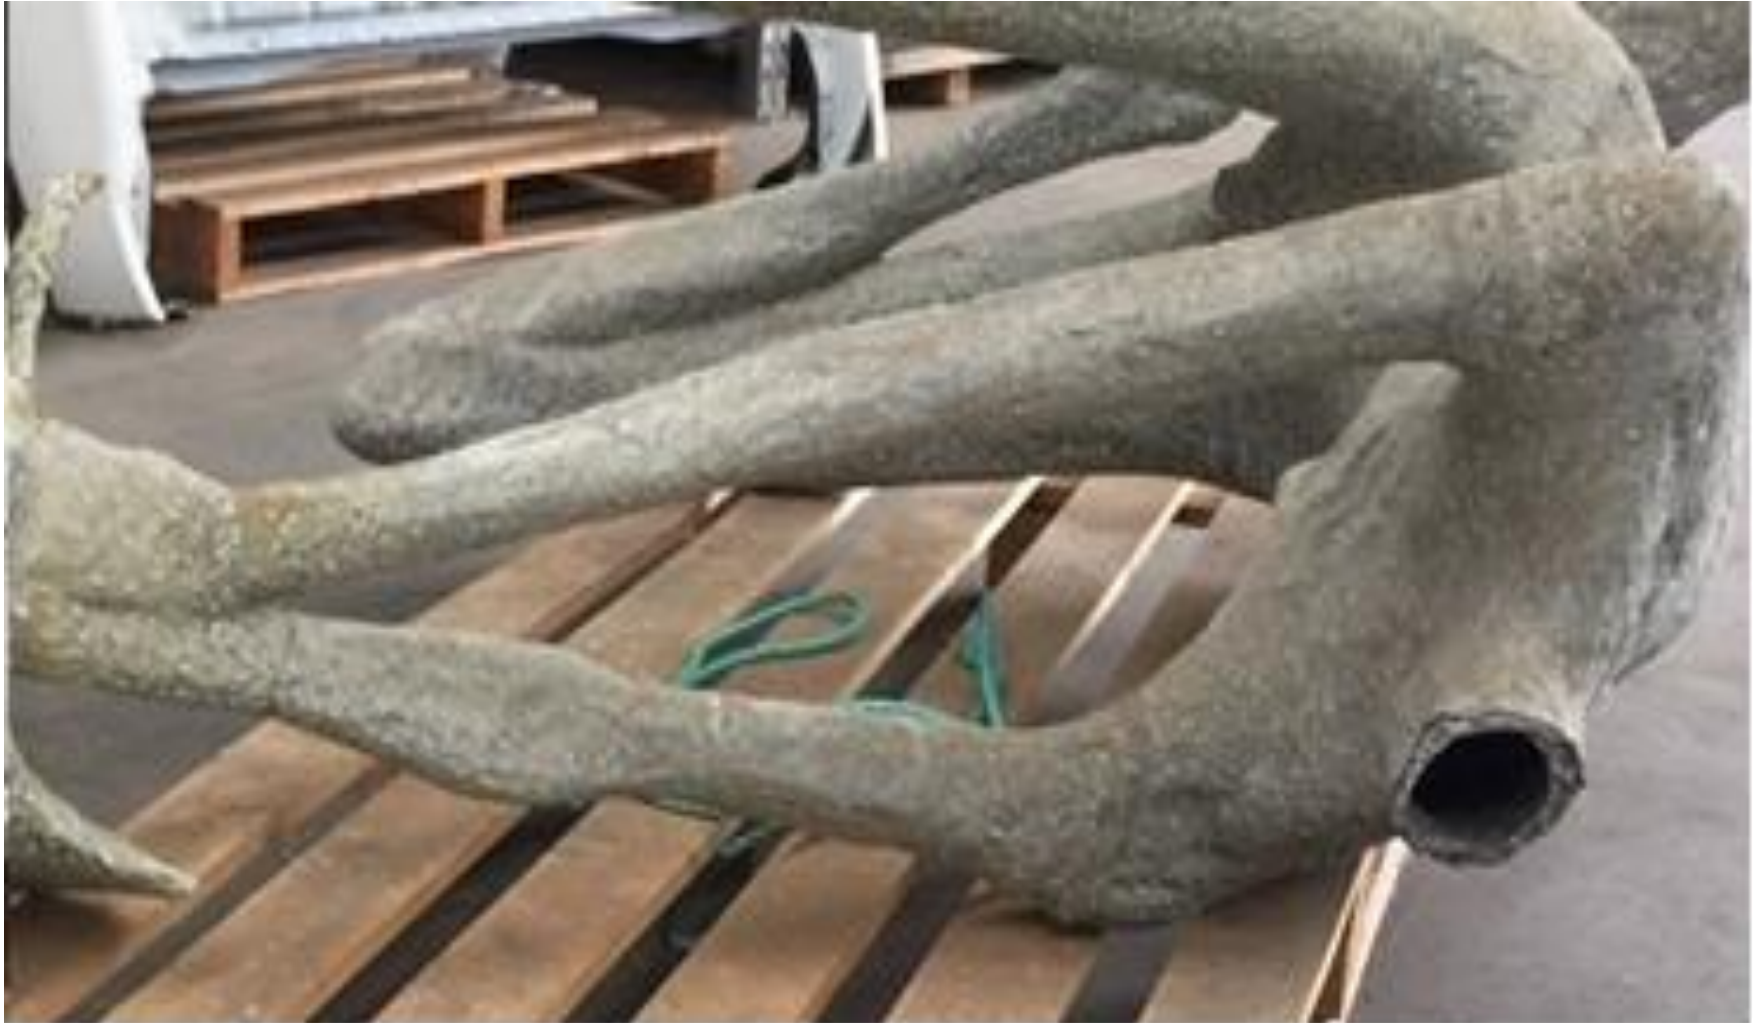
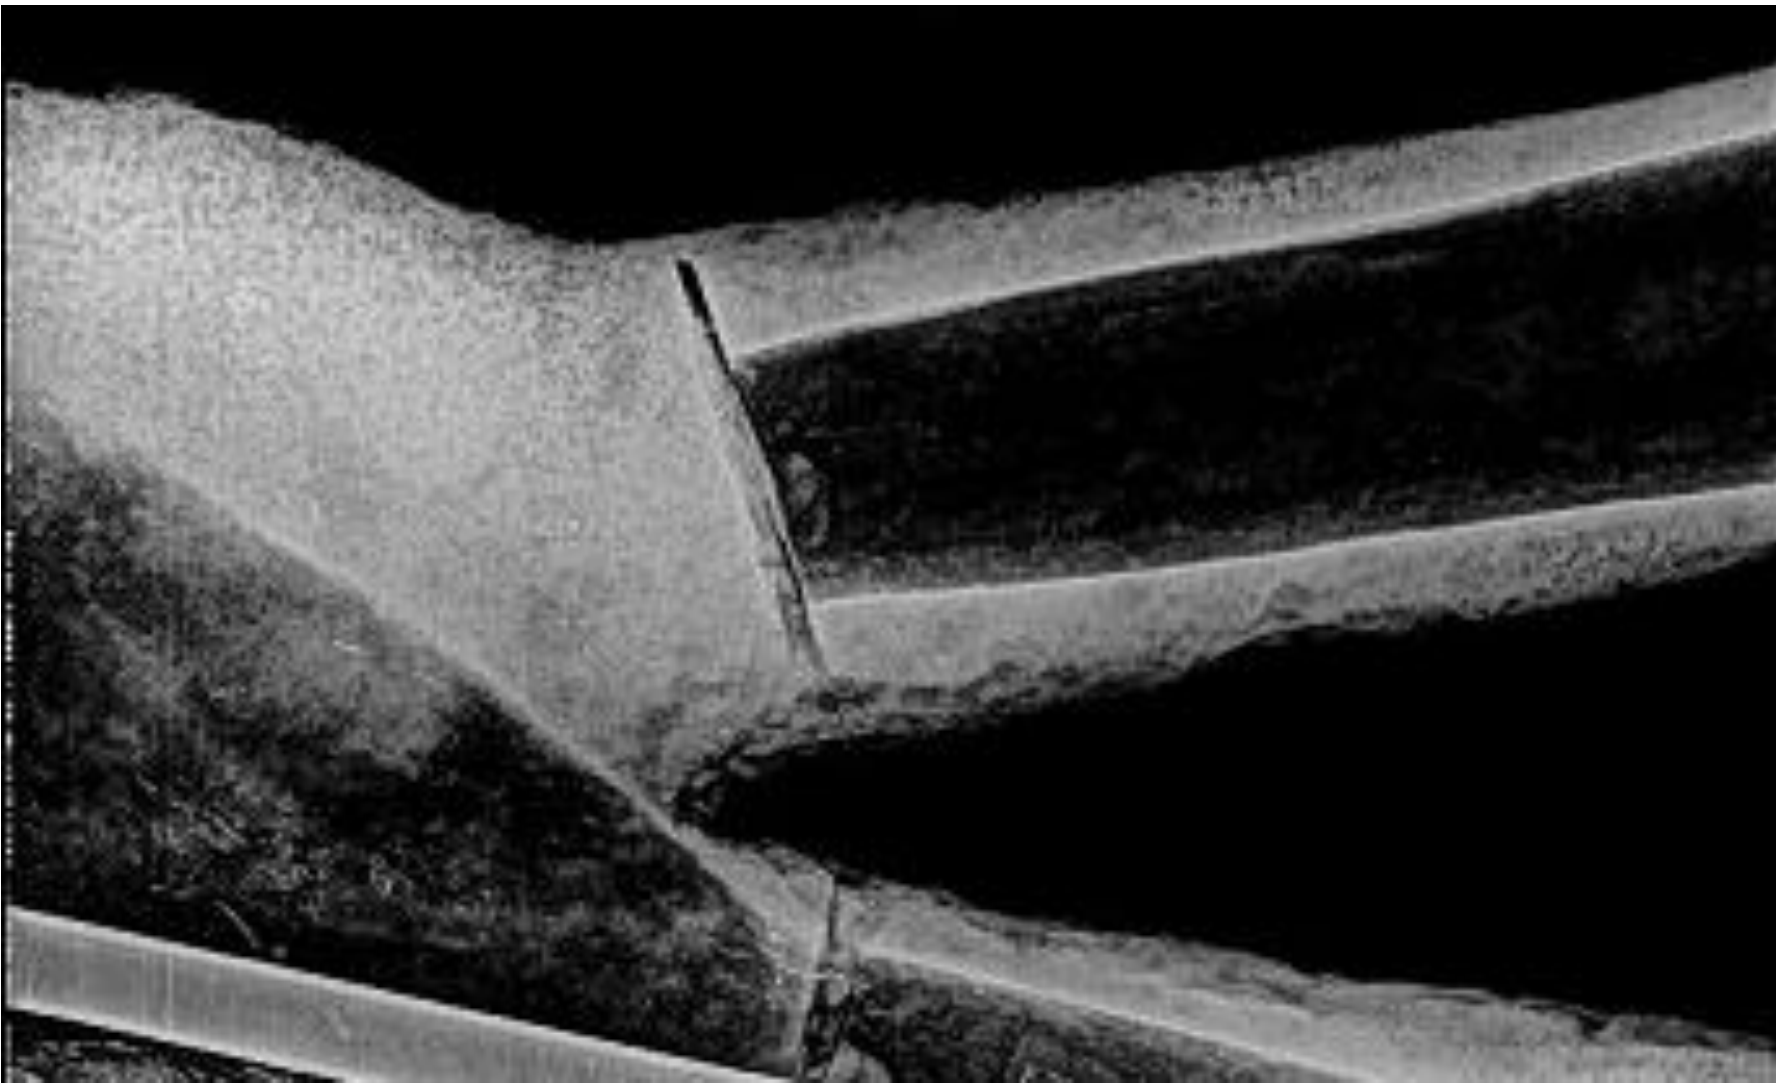
# Upper torso and arms

Incomplete weld penetration with cracking evident in the weld and parent metal in the lower arm section

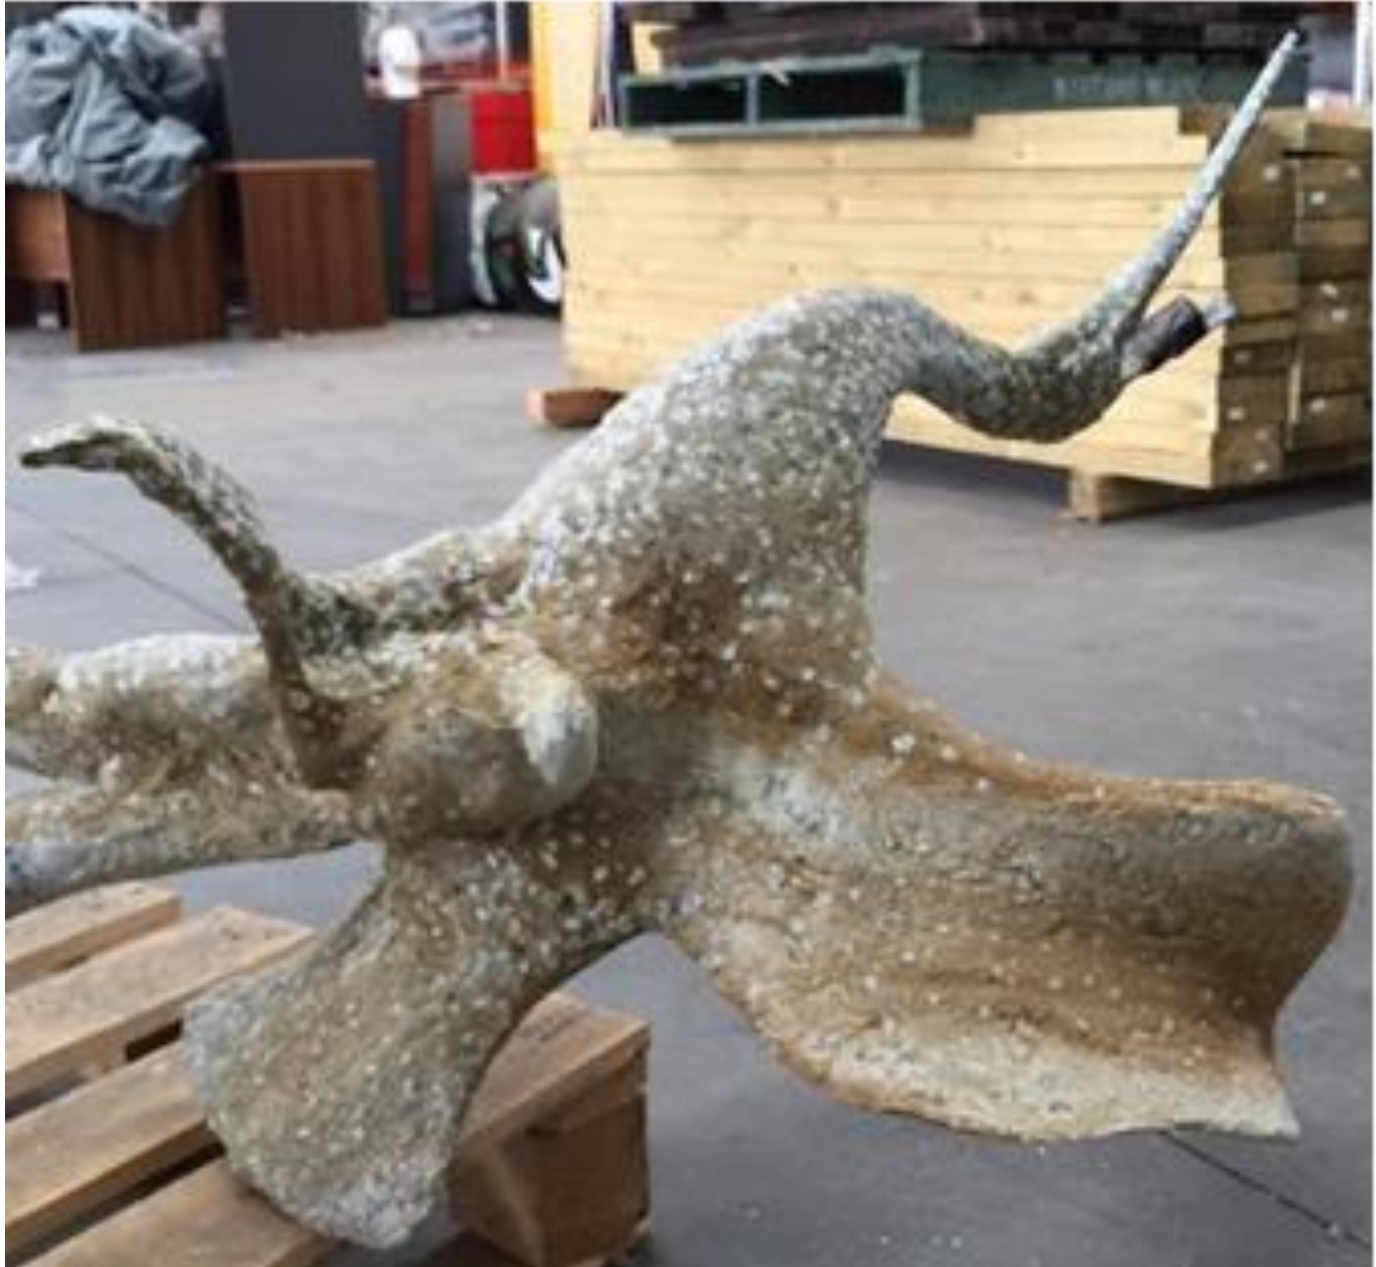
# Ibis

Visible areas of corrosion evident, wall loss located at the neck area below the head and the lower beak adjacent to the metal insert.

Parent metal thickness  $>10\text{mm}$   
Water pipe cast into head section.
