# RECOGNIZING THE VALUE OF STORAGE TANK BOTTOM MFL INSPECTION DATA

Victor J. Escobar  
NDTiC 2017  
Quebec City, Quebec  
June 6 - 8 2017

NDT in Canada  
**NDTiC 2017**  
Canada's NDT Conference

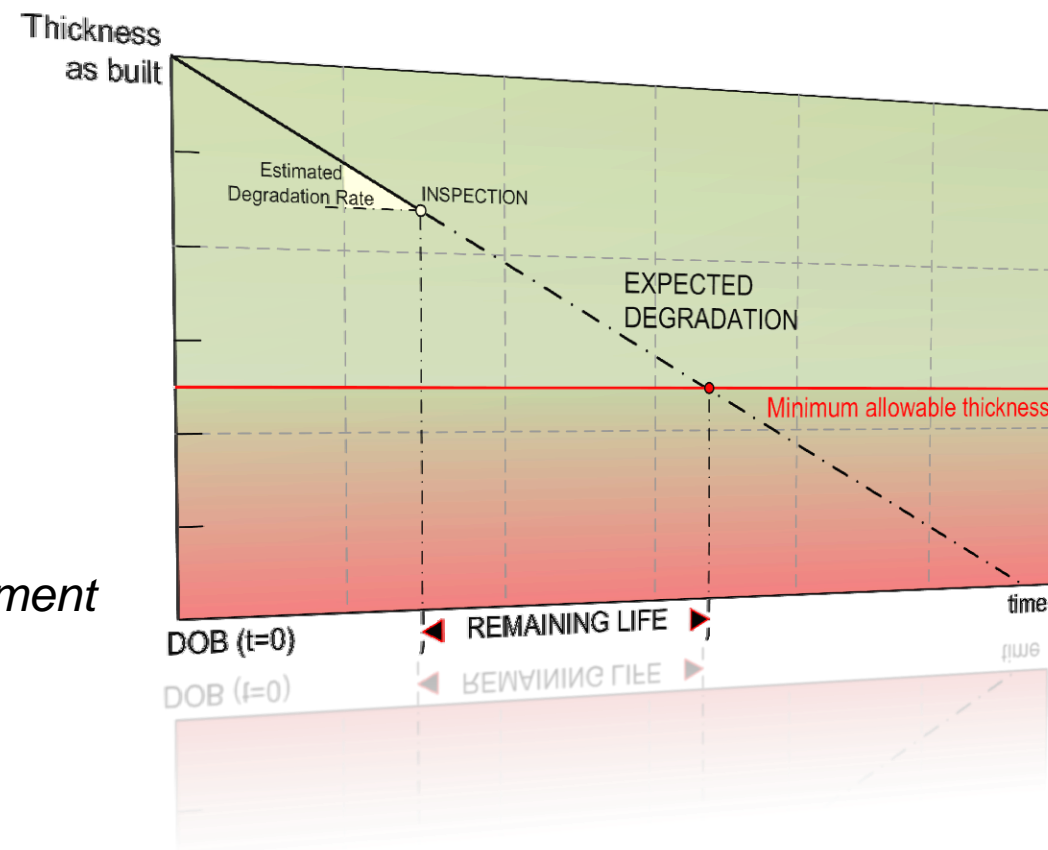
- *Isolated versus clustered pitting versus general*
- *Pit-on-a-pit is very unlikely*
- *Pitting is in most cases govern*
- *Corrosion process differs between internal and external*
- *Internal Corrosion: more or less predictable,  $f(\text{product})$*
- *External Corrosion: unpredictable, case-to-case assessment*
- *CP installed, however external corrosion present*
- *Linearity of CR – no models available*

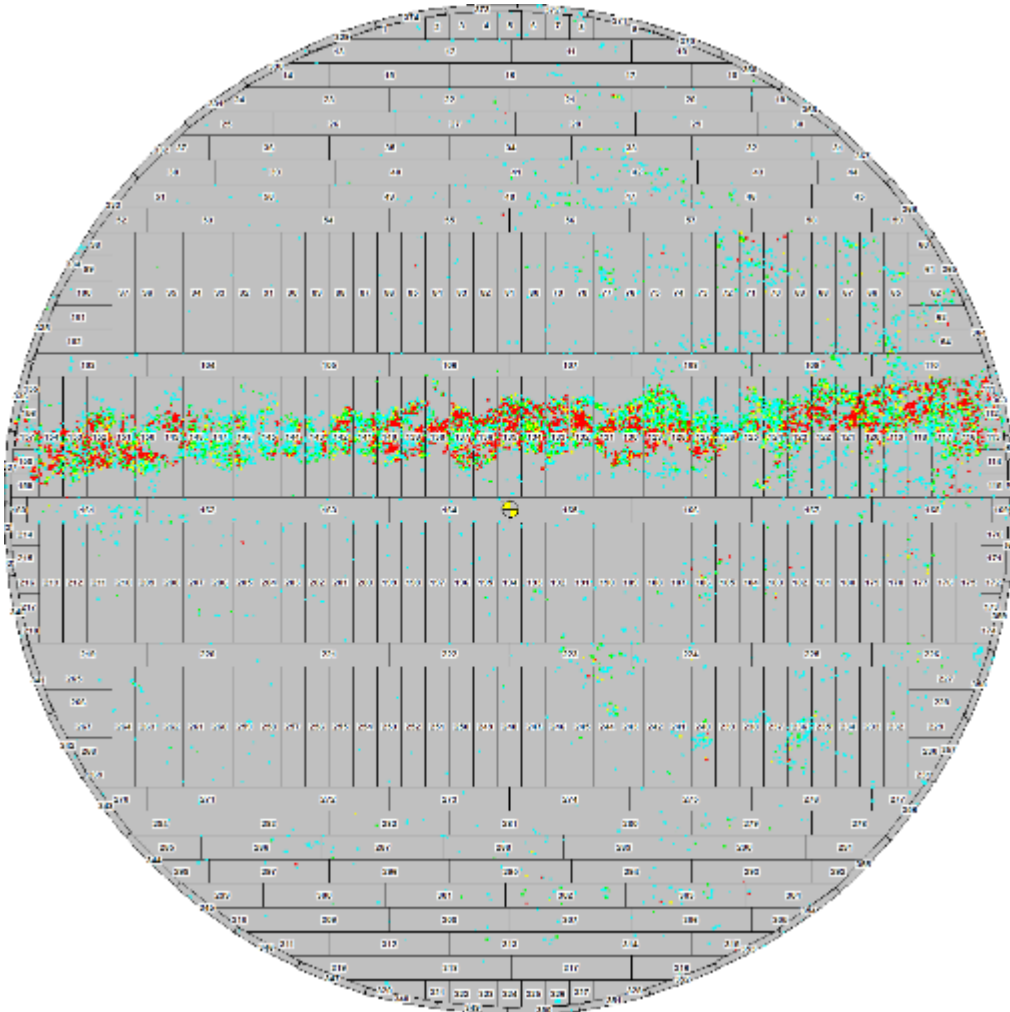
# CASE STUDY - 1

- Crude Oil Storage Tank
- Diameter – 245 ft (75 m)
- Region – Gulf Coast
- Age – 8 years
- Coating – Thin film epoxy
- CP system - Yes

- External severe corrosion
- Centralized corrosion pattern

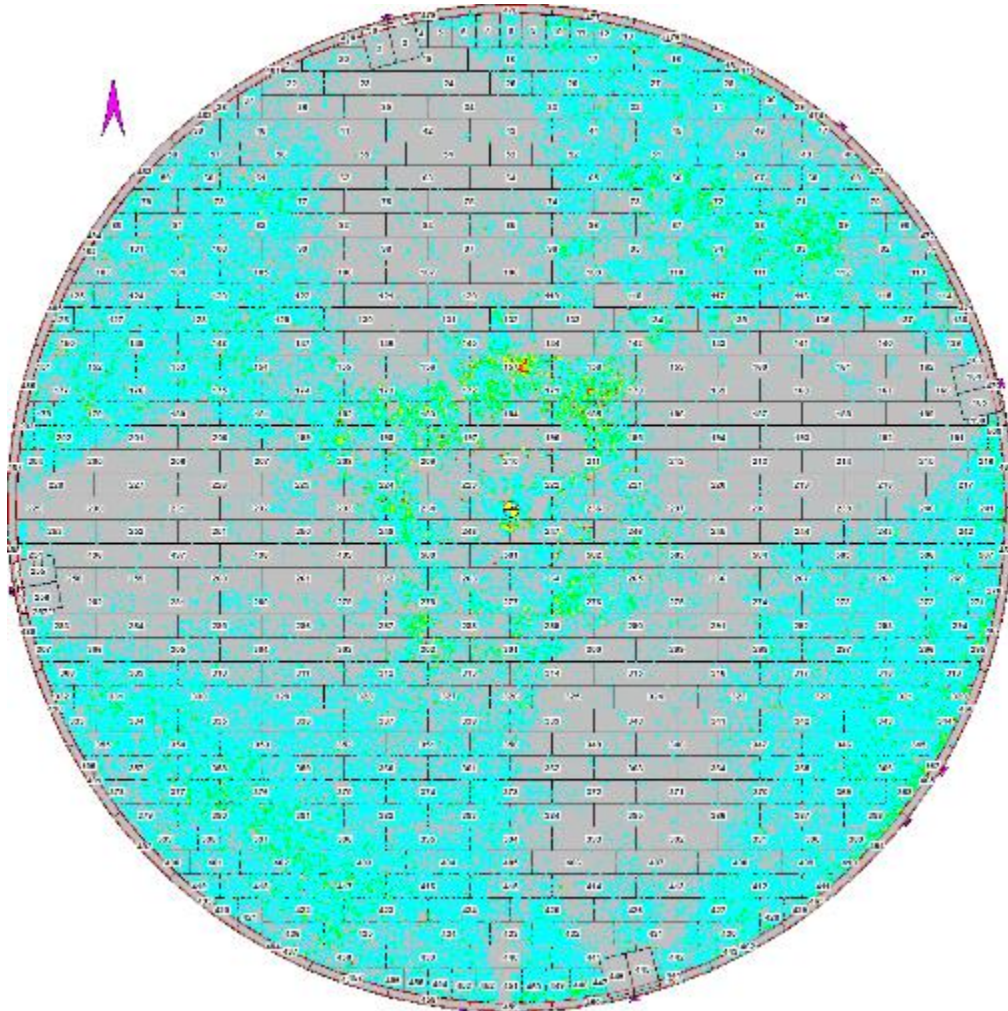
# CASE STUDY - 2

- Crude Oil Storage Tank
- Diameter – 279 ft (85 m)
- Region – Central
- Age – 15 years
- Coating – Film epoxy (30 mils)
- CP system - Yes

- Internal severe corrosion
- Corrosion pattern
